TOP FLOOR FLAT, BONNYGATE, CUPAR

ESSENTIAL REPAIR, MAINTENANCE AND THERMAL UPGRADES

Energy Efficiency Case Study: Flat in Bonnygate, Cupar

19th March 2019

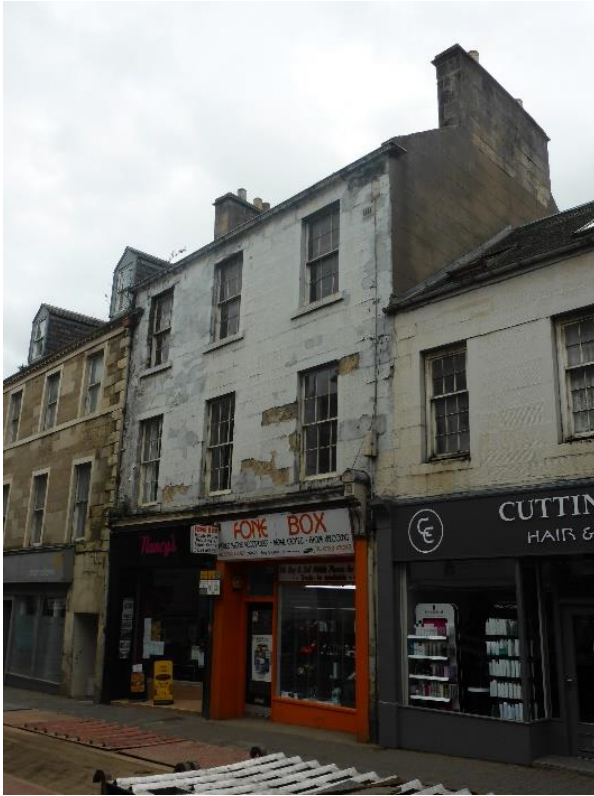
Water ingress through the roof was identified in two locations. A thin coat of cement render and significant areas of delaminating (flaking) stone were found on the front elevation. Extensive masonry pointing and localised stone repairs were required on the rear elevation. Most of the windows were in a fair to poor state of repair. Rainwater goods (guttering) needed to be cleared and re-fixed and some local vegetation needed to be removed.

Fig. 1. Front elevation before works

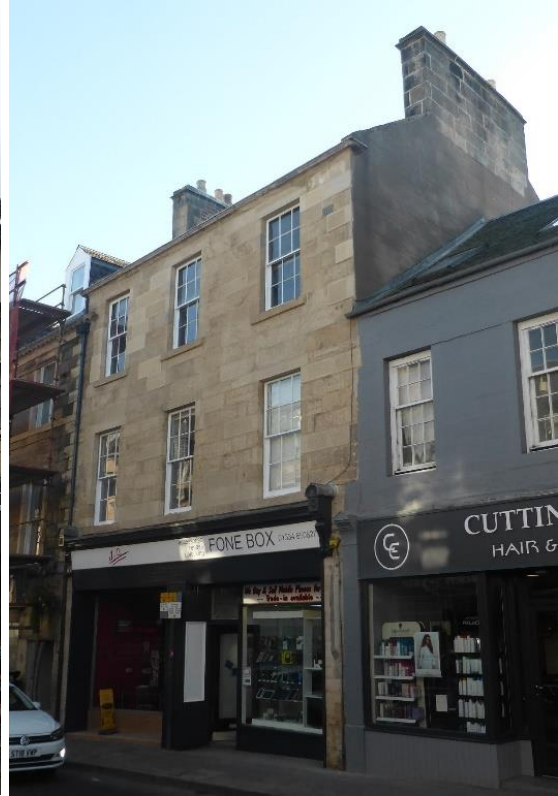
Fig. 2. Front elevation after works

The works included repairs to the roof and the guttering, reinstatement of the shop front, removal of cement and paint to the front, extensive masonry repairs, significant masonry pointing, window and door repairs and draught stripping and a top up of loft insulation. All work was carried out in line with the principles of conservation best practice, retaining original features and matching sandstone and slates to the original. Cement mortar was removed and replaced with traditional lime pointing.

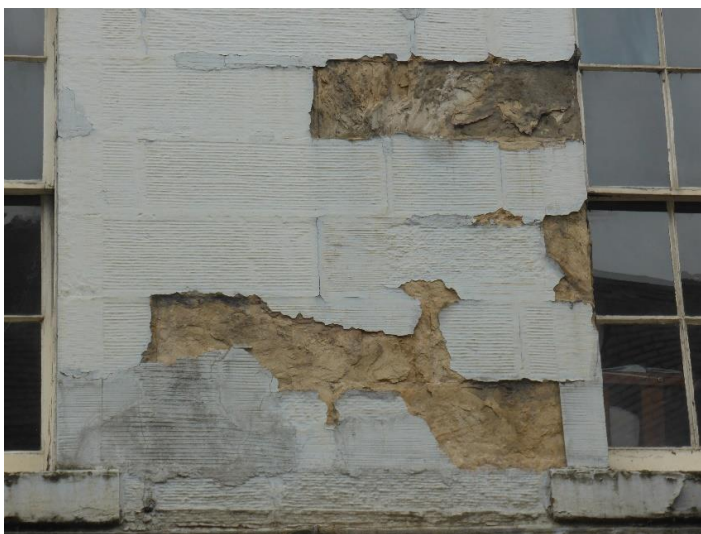
Fig. 3. Front elevation before detail

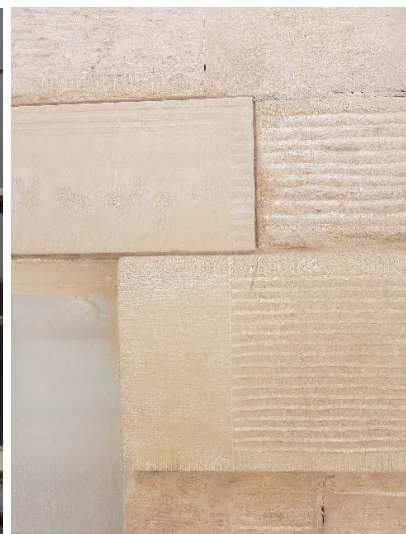
Fig. 4. Front elevation after detail

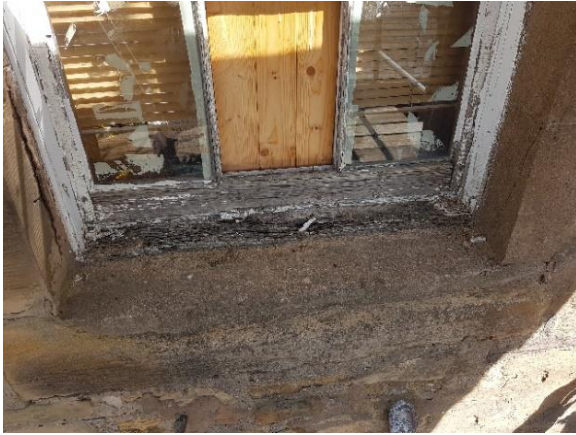
Fig. 5. Existing rear window before overhaul

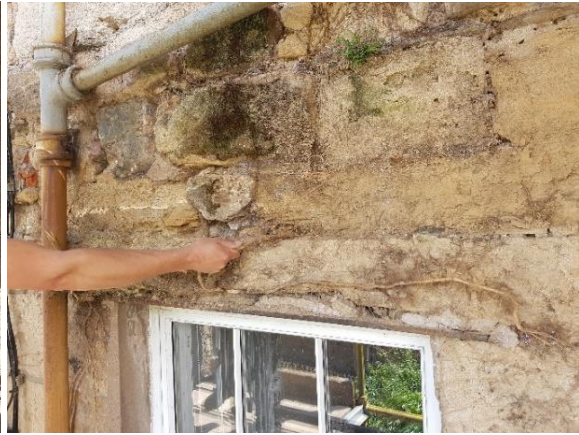
Fig. 6. Existing vegetation roots in masonry

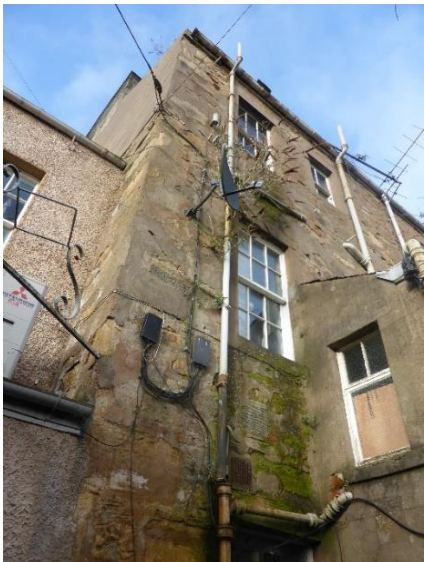
Fig. 7. Vegetation resulting from rainwater leaks

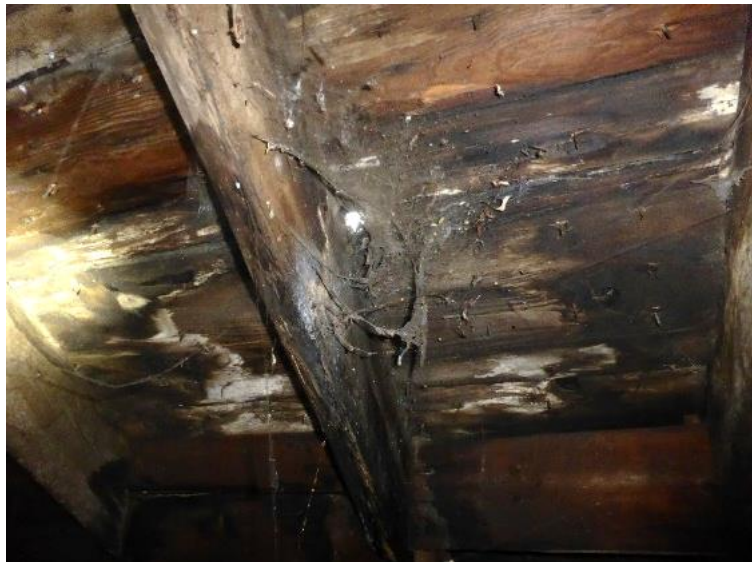
Fig. 8. Water ingress through roof (note daylight)

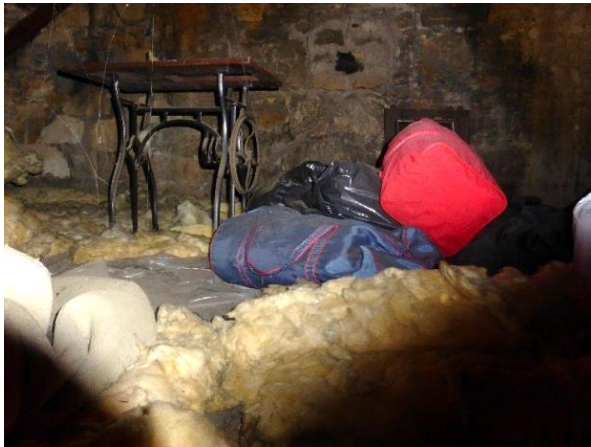
Fig. 9. Attic insulation before works

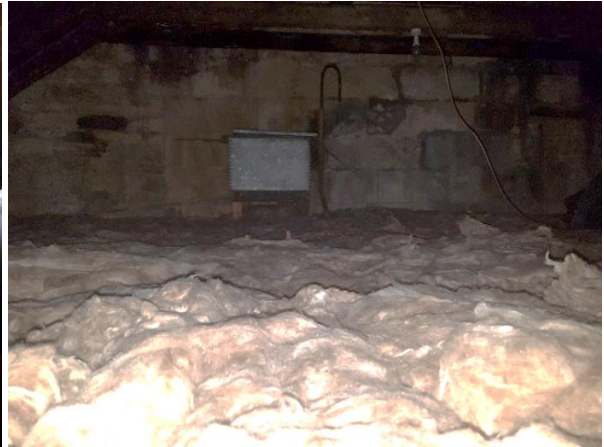
Fig. 10. Attic insulation after top up

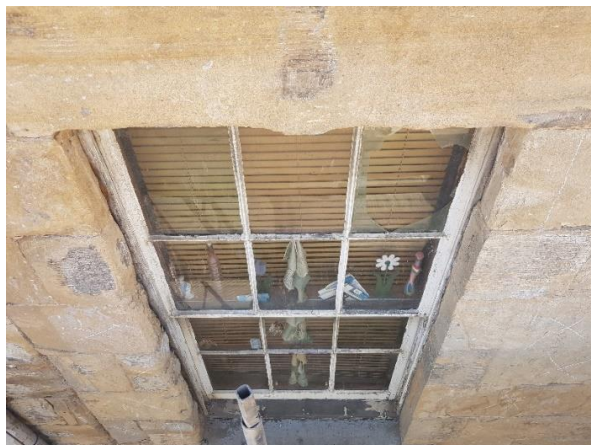
Fig. 11. Typical front window before works

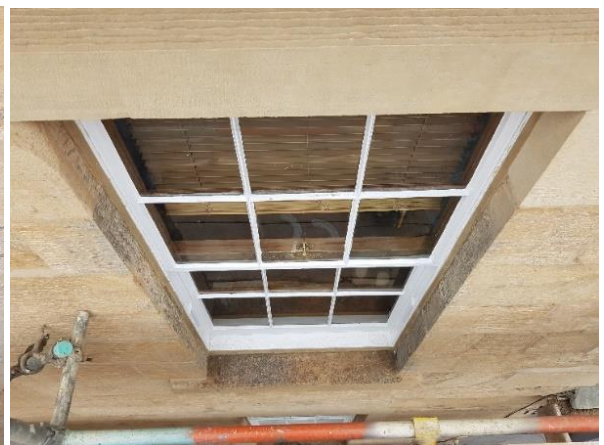
Fig. 12. Typical front window after works

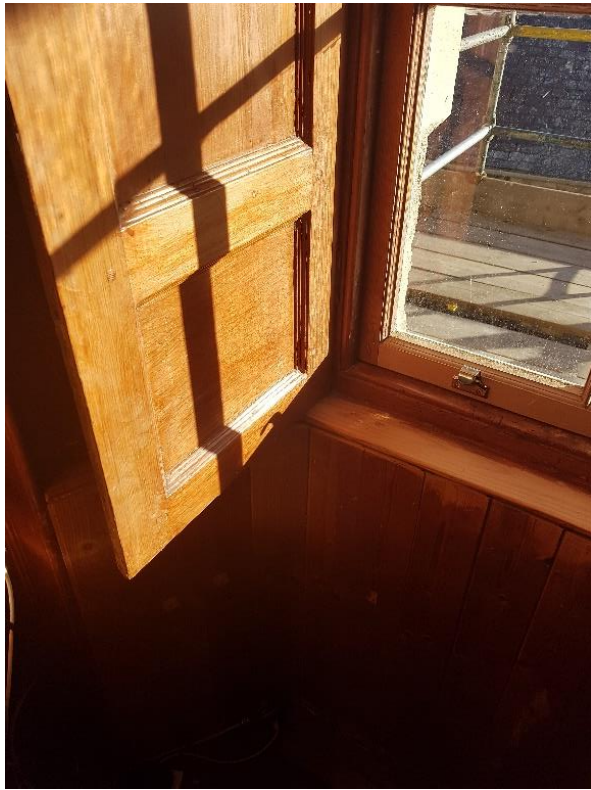
Fig. 13. Sash window repair

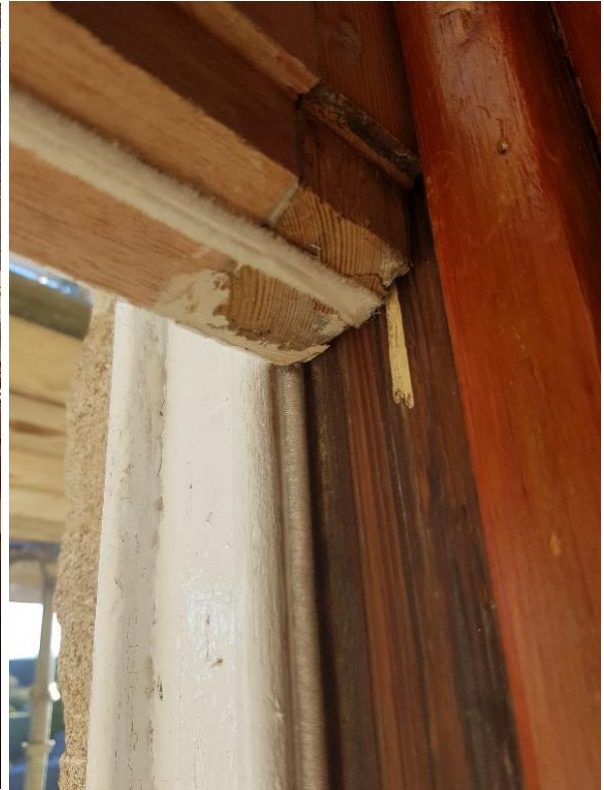
Fig. 14. Draught strips added to windows

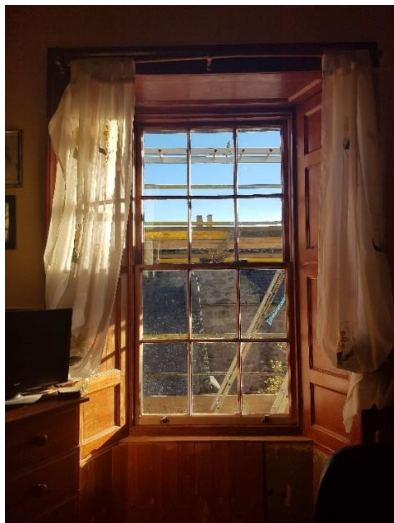
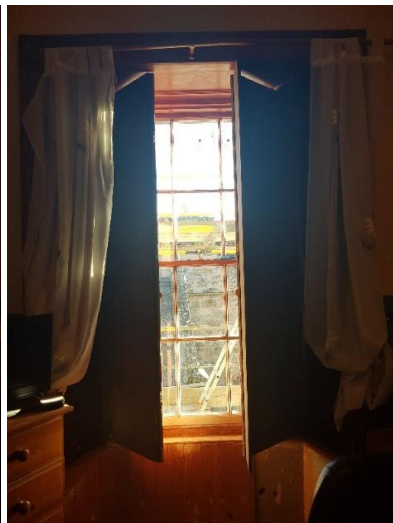
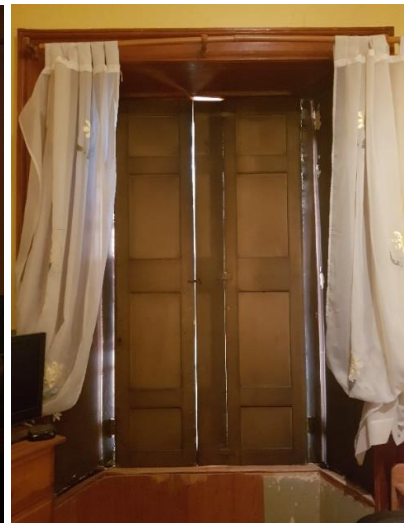
Fig. 15a–c. Rear window shutters restored (inside of window in Fig. 5)

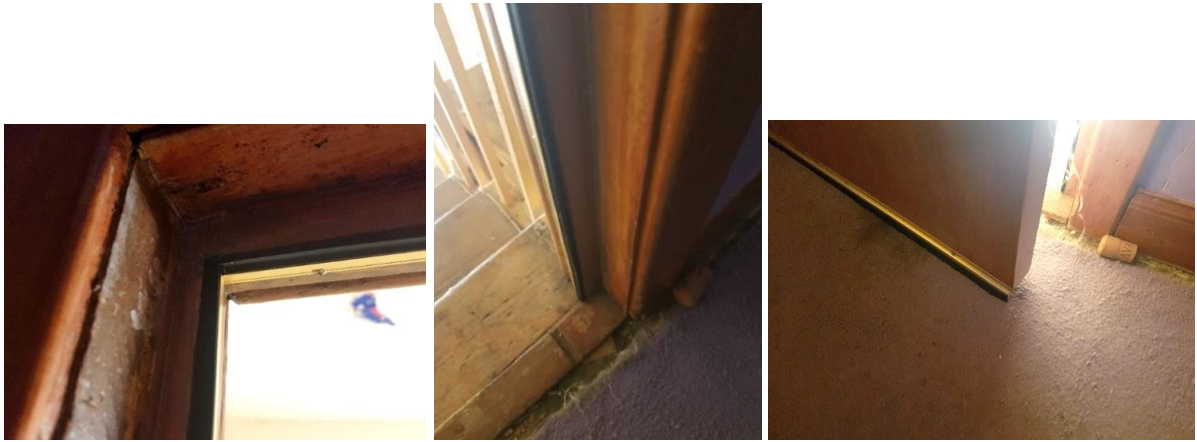
Fig. 16a–c. Front door draught strips

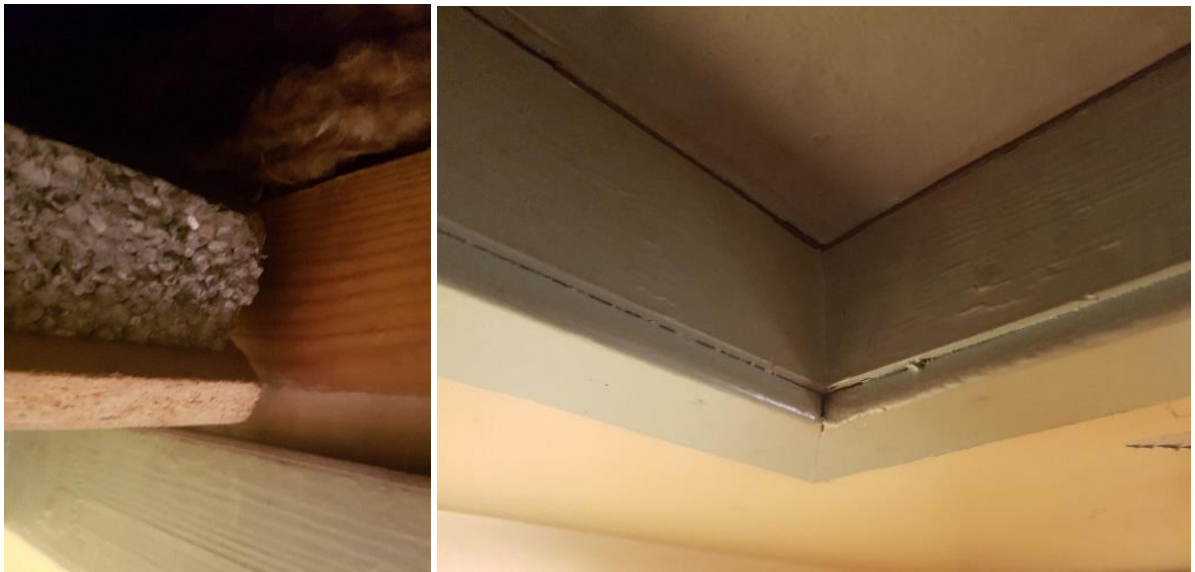
Fig. 17a–b. Loft hatch insulated and draught stripped

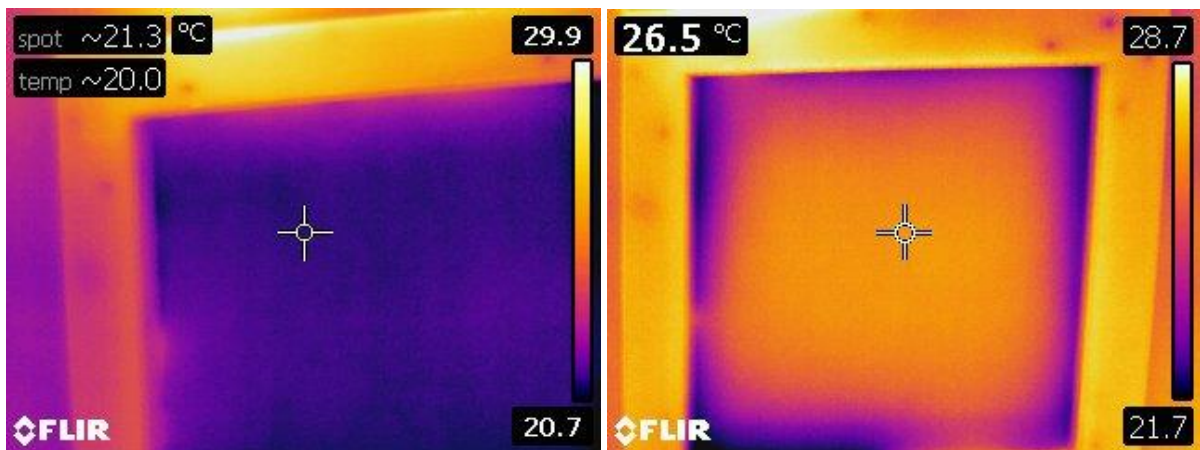
Fig. 25a–b. Before (left) and after (right) thermal images of the flat's loft hatch, showing significantly less cold (dark)

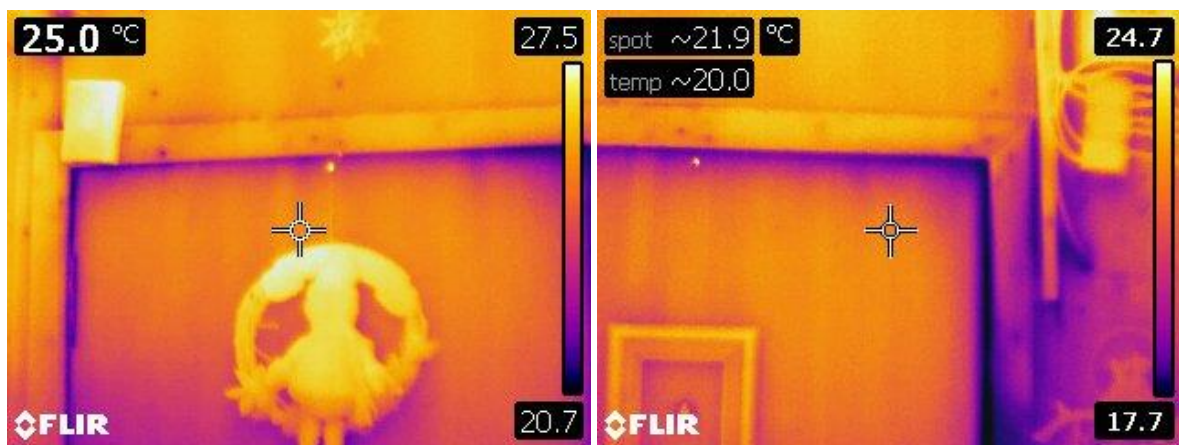
Fig. 26a–b. Before (left) and after (right) thermal images of the flat's front door, showing slight improvement in cold tracking into flat (dark)
