Cupar Stone and Slate Survey

As part of the Cupar Conservation Area Regeneration Scheme (CARS) and Townscape Heritage Initiative (THI) operated by Fife Council and Fife Historic Buildings Trust, the Scottish Lime Centre Trust has undertaken a stone and slate building survey of the historic centre of Cupar to give a better understanding of the condition of the buildings and future conservation needs.

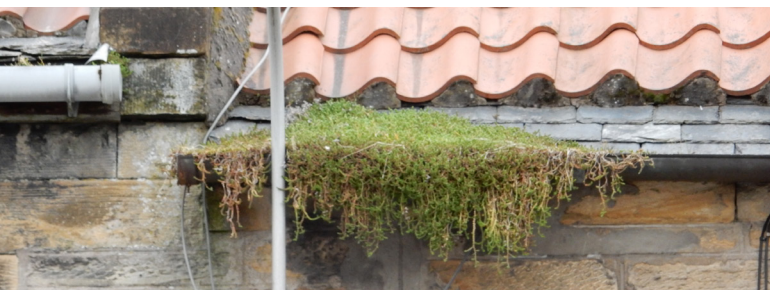
- General lack of maintenance and repair particularly of rainwater goods
- Large amounts of vegetation growth along the roof lines
- Masonry decay leading to structural problems particularly at chimneys

Vegetation growth in a gutter causing a blockage

- Removal of vegetation growth
- Cleaning out, repair/replacement of rainwater goods where necessary
- Removal of cement pointing where this is causing damage
- Repointing using lime mortars
- Replacement of eroded stone
- Stabilisation of chimneys and other parts of the building where necessary
- Removal of impervious and cement paints
- Organise common repairs for buildings in multiple ownership (see newtenementhandbook.scot).

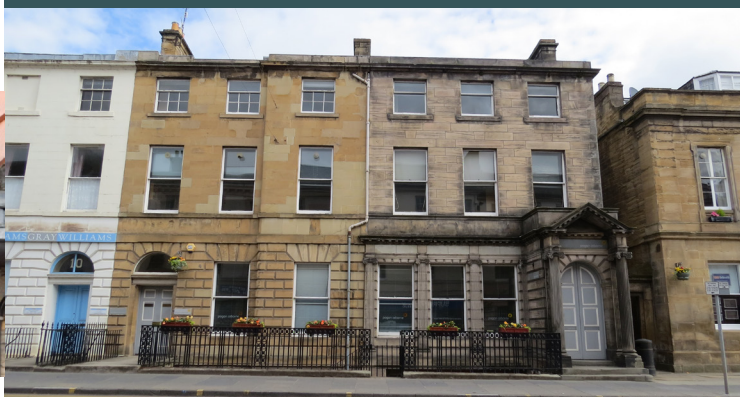
The two stone types of Cupar: the local buff sandstone (centre left) and the grey sandstone (centre right)

Cupar is built with two main stone types, the local buff sandstone as well as a better quality grey sandstone, possibly sourced from further away (see image overleaf). The buff sandstone in particular displays large areas of delamination and granular decay.

- Replace structurally compromised building stones with suitably matching stone.
- Remove cement based or moisture impermeable masonry paints and replace with lime paints or mineral paints. Paint removal is an intricate process which has the potential to damage the stone underneath and requires individual specification. For more information see the full survey report.

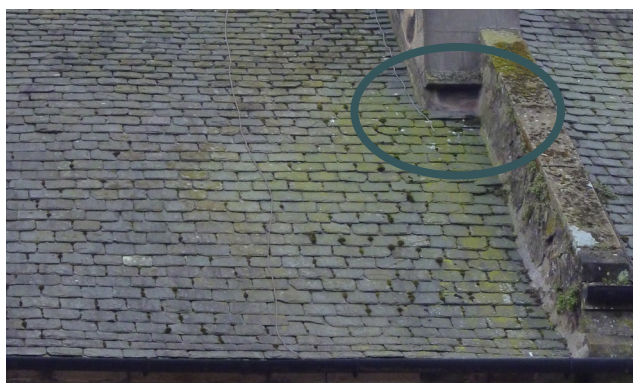
Also notable are the thack-stanes found at the base of many chimneys, indicating that the building was thatched in the past.

A traditional roof with random diminishing coursing and a thack stane (circled)

The exact origin of the slates used in Cupar is not definitively visually identifiable. Nevertheless, it is important to match the type of slate as well as the craftsmanship when repairing roofs. As such, the best replacement is reclaimed second hand slate with matching colour, texture and size, laid by a skilled roofing contractor with a good understanding of traditional roof coverings and in keeping with the coursing. Much of the Scottish slate was laid in random diminishing courses, as shown in the picture above. It is also considerably thicker than Welsh or Spanish slate.

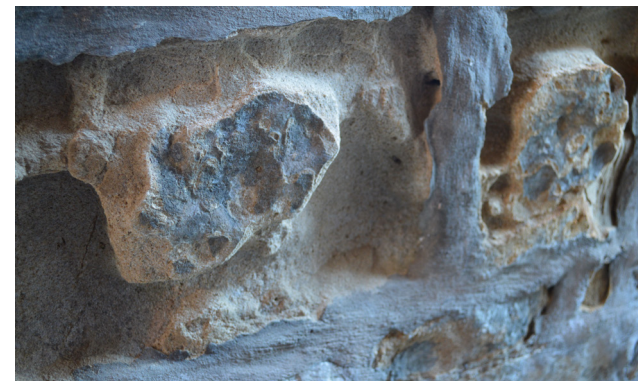
Throughout Cupar, a number of buildings have more recently been rendered or harled with cementitious mortars. This has often had a negative impact on the stone underneath, leading to severe decay.

Damage to stone caused by cement pointing

- Repoint masonry where necessary using lime mortars, particularly at high level, chimneys and open vertical joints in masonry
- Remove cementitious materials and repoint/render in lime based materials
