A Building Stone Survey for Cupar Conservation Area, Cupar, Fife

Carried out by the Scottish Lime Centre Trust

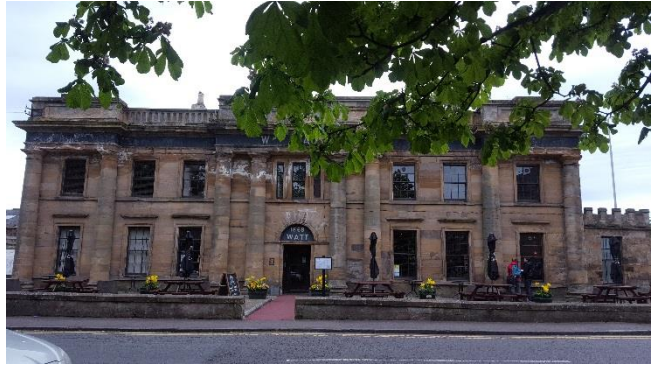
Ashlar with hood mouldings around windows. Doric columns, overhanging cornice, parapet masonry. Salts, delamination under hidden rainwater goods. Stone in very poor condition, delamination. Some cement repairs, rendered/plaster over. Vegetation growth on parapet. Urgent: stone loose at west gable just below head of column; dowels visible at cracked stonework of end bay.

The managerial staff have informed us that fallen pieces of masonry have been found

Figure 3: Watt's Pub.

before following bad weather, and in response they have moved the outdoor dining areas away from these areas. It is therefore quite urgent that these high level areas of loose masonry be attended to immediately to avoid any risk of masonry falling onto the public below. The repairs required to the building are predominantly stone replacement and repointing empty joints as this is the most widespread problem. There are previous surface repairs that require removal as these are causing damage to the stone and have been carried out in dense, cement based mortars. This is due to the poorer stone quality having eroded away at exposed areas, requiring surface repairs and thus the cement mortar has not solved the problem but made it worse. Surface repairs are only a 'sticking plaster' method of repairing stone, particularly if carried out in cement with soft sandstone as this can lead to further decay. However, if the correct materials are used, with the right methods and a skilled worker then it can be a means to revive lost details in carved stone.

- Extensive stone repairs required to loose, cracked and damaged masonry – stone replacement required urgently
- Surface repairs and repointing required to less decayed stone
- Salts require brushing off at parapet level
- Investigate concealed gutter as clearly there is a problem with water at the parapet
- Full condition survey required for remedial works

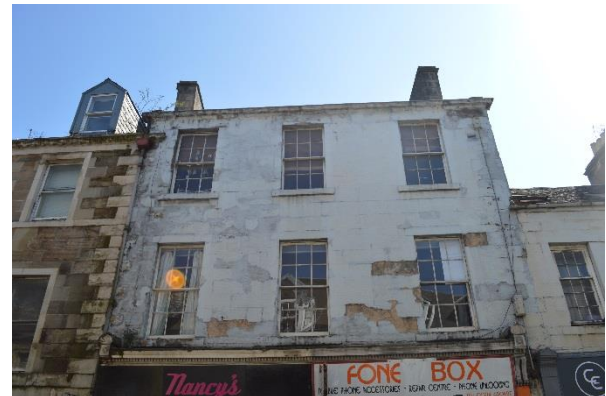
This property (Figure 4) highlights the effects of the inappropriate use of dense materials on soft sandstone, and also the lack of maintenance that can cause damage. The stonework has been repaired so many times using various materials, it is almost impossible to make out the original fabric. As some of the render, cement wash or paint has fallen off in areas, this allowed us to identify the stone beneath. The external condition of this target

Figure 4: 8 Bonnygate.

building is extremely poor, as the stone is quite soft

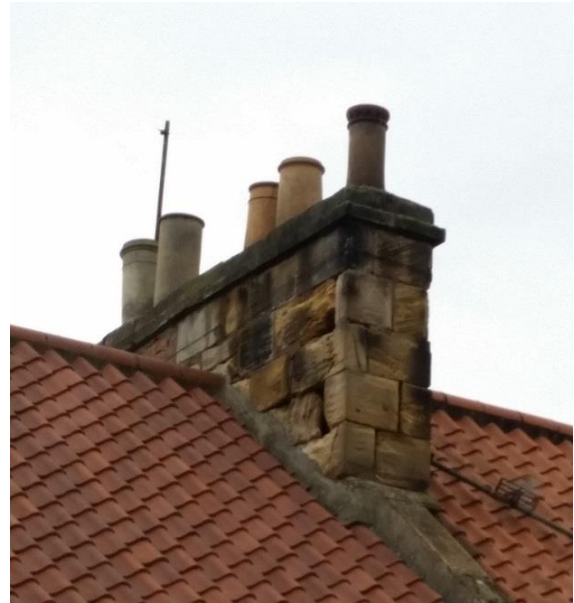
Urgent repairs are required at 44 & 46 Kirkgate (shared) where the chimney stack has an alarming amount of fabric loss due to various reasons (Figure 5). These are most likely cement mortars being used on a soft sandstone causing the stone to erode at a very exposed area, potentially sulphate attack could be causing stone decay, and the poor quality of stone being used with no protection from the weather. This chimney would require taking down and rebuilding, with some replacement stones bedded in robust lime mortars. It may also prove prudent to render the chimney in a weather proof lime render to prevent this extent of decay from happening again in the future.

Figure 5: Chimney of 44 Kirkgate.

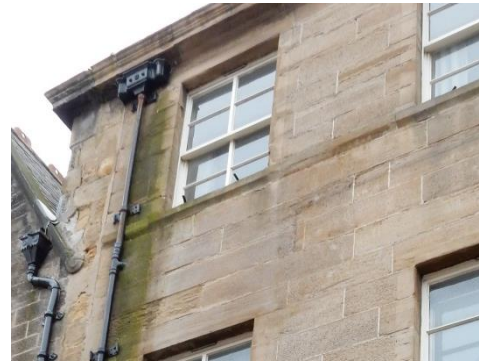
The most prevalent problems that were evident in the findings were related to the maintenance of the rainwater goods and repointing of buildings. It was established that the vegetation growth has a direct correlation to the failure of the rainwater goods, as the vegetation was thriving on the water which was not draining away adequately and debris from blockages. An issue which affects most of the inner part of Cupar is a lack of space for accessing roofs and rainwater goods, due to the roads and pavements being quite narrow and busy. It is likely that this is a

Figure 6: Blocked rainwater goods causing vegetation growth on the façade of 20 St. Catherine Street.

contributing factor in the neglect of rainwater goods in the Priority Area. Another factor that was taken into consideration was that most of the properties affected have more than one property and therefore multiple owners, and it is a possibility that the residents may not be working together to clean and maintain the rainwater goods (Figure 6).

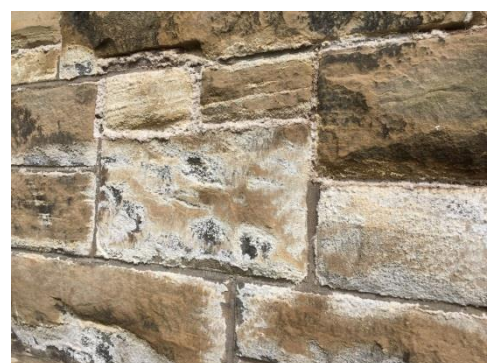
The findings also showed that the buildings badly affected by salt crystallisation were predominately in the areas out with the Priority Area with 7% of the buildings showing the presence of salt crystallisation, where as in contrast only two of the buildings within the Priority Area with salt crystallisation (Figure 7). This is thought to be due to the fact that the majority of buildings in the Priority Area are painted at ground level or have a plinth course which stops salts from forming by excessive wetting and drying cycles or by road grit, therefore not showing on the façade.

Figure 7: Efflorescence on the façade of West Port flats.

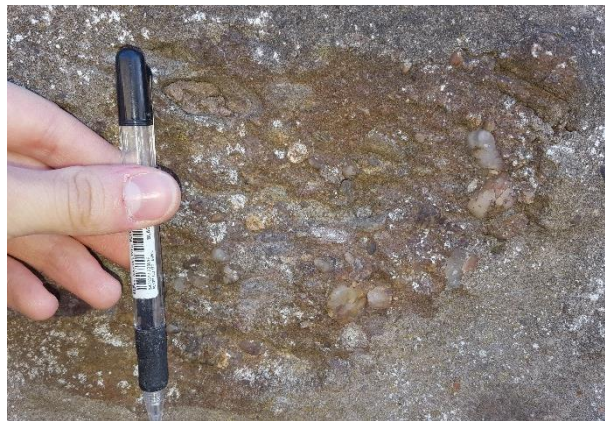
Figure 14: Block of conglomerate in-situ within the east boundary wall on Bishopgate. The block is surrounded by cement overpointing. Pencil used for scale measures ~15cm length.

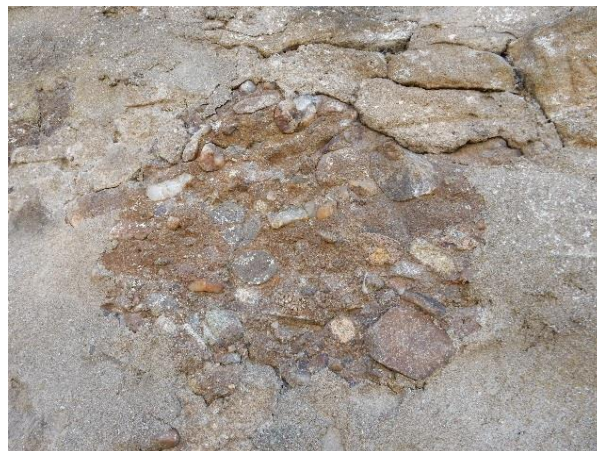
Figure 15: Block of conglomerate in-situ within the east boundary wall on Bishopgate, surrounded by cement overpointing. The largest quartz clast (centre right) measures ~8 – 10cm in length.

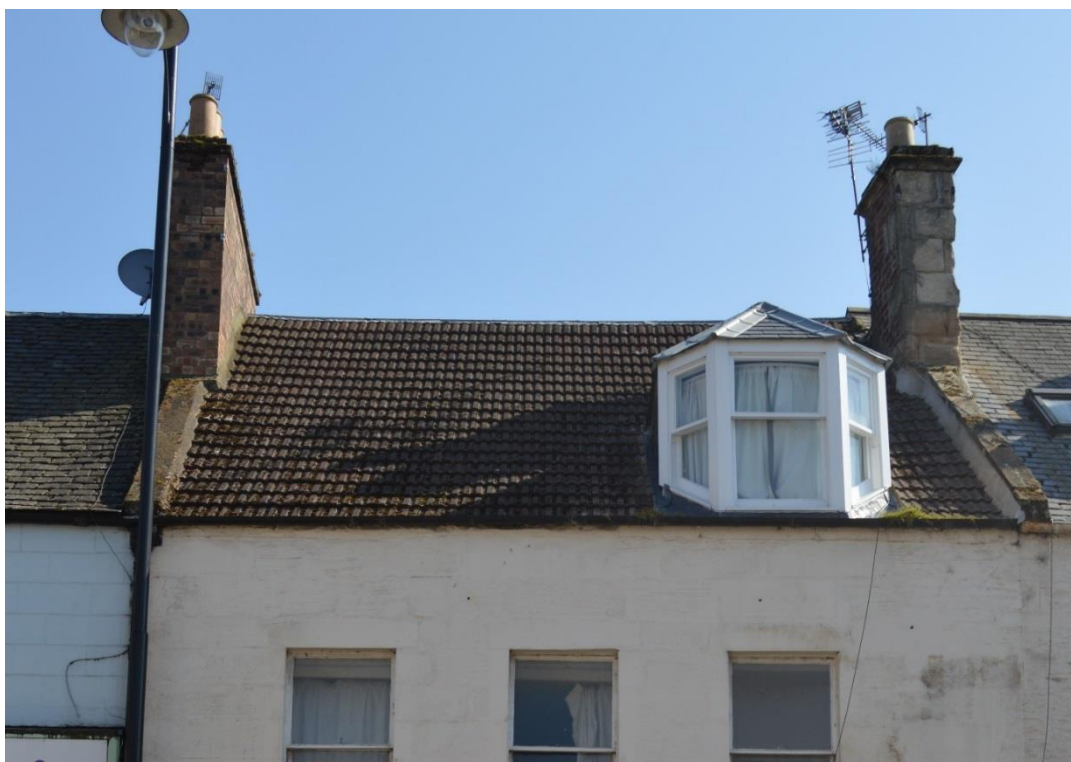
Figure 26: 52-54 Bonnygate demonstrating concrete tile replacement, with traditional slating to the left and tally slating to the right

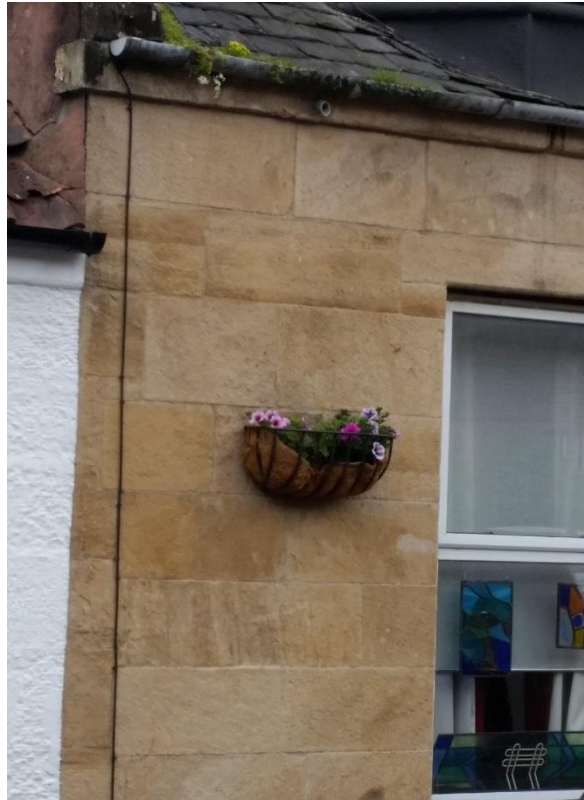
Figure 27: 28 Provost Wynd, demonstrating scutch finish next to traditional stucco finish (on left)
