Chimney Collapse: The Cause and Process for Repair

Case study: No. 1 The Barony, Cupar

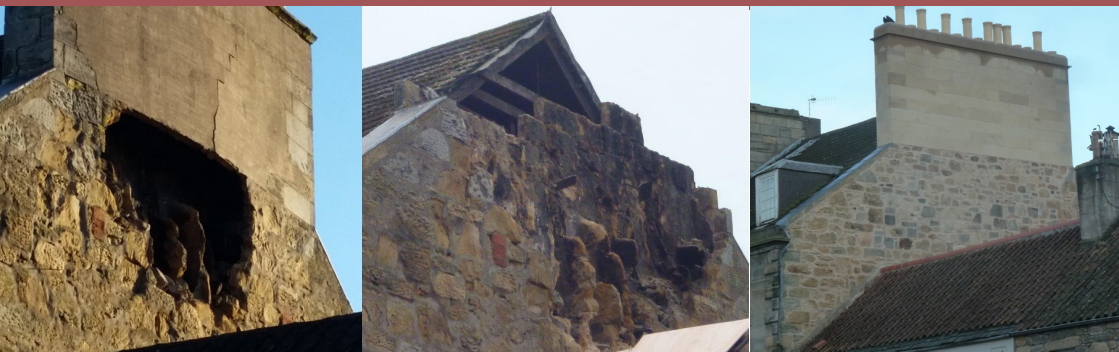
During a period of poor weather in 2016, a section of masonry supporting the chimney collapsed, falling through the neighbouring roof. Fortunately no persons were injured although the chimney remained vulnerable and hazardous to the neighbours and public.

Due to the threatening condition of the freestanding chimney stack, Fife Council enforced an emergency part closure of the street and dismantled all high level masonry to the lowest point of the collapse.

The owners of the property formed an owners association and employed a Conservation Accredited Architect and local contractor to rebuild the area of collapse. The wall and chimney were repaired using appropriate materials and traditional techniques which are sympathetic to the listed building.
