STONE ANALYSIS & MATCHING REPORT

AP 2898
Cupar Stone and Slate Survey,
Freemason's Hall,
Cupar

AP 2898
Cupar Stone and Slate Survey,
Stephen Gethins MP Office,
Cupar

AP 2898
Cupar Stone and Slate Survey,
Watts Pub,
Cupar

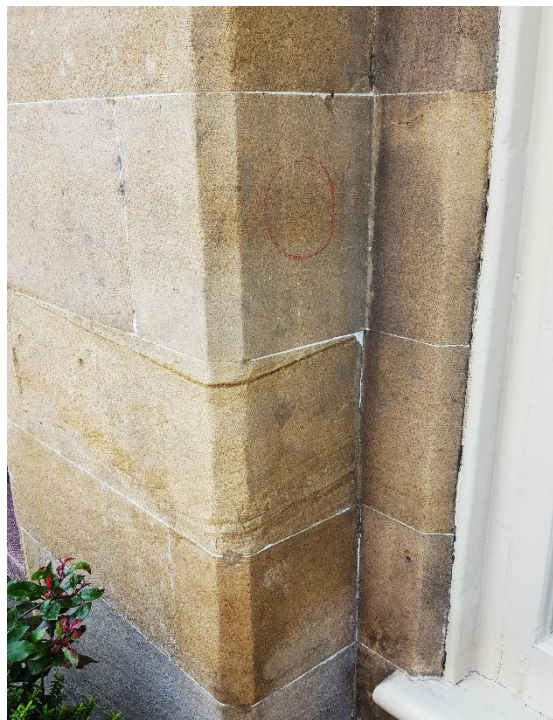
Plate 1. The sandstone sample was cored from the area highlighted by the red chalk circle. This area was representative of sample 4-type sandstone and was cored from a section of the stone that wasn't directly street facing.

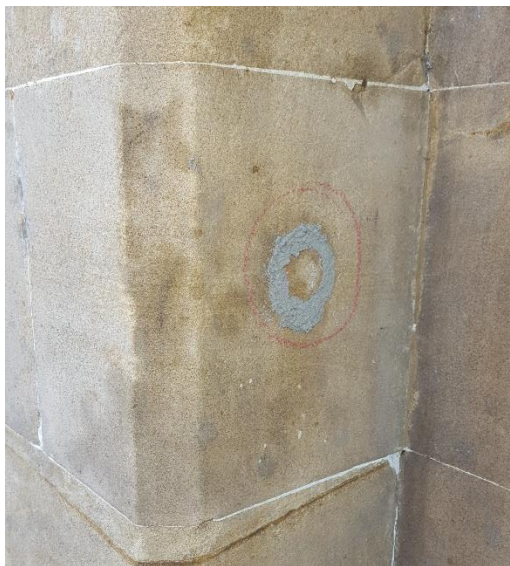
Plate 2. View of the backfilled cored area of the stone.

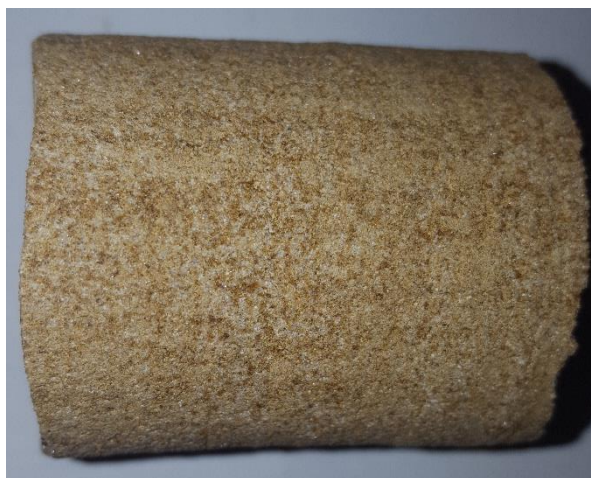
Plate 3. Side view of the sandstone core post thin section preparation. The thin section was cut parallel to the length of the core.

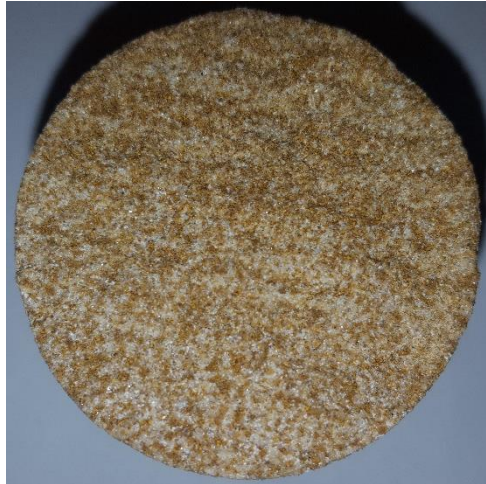
Plate 4. End view of the sandstone core post thin section preparation. Distinct Fe-oxide and clay mottling is present, while slight bedding alignment is visible towards the top of the core.

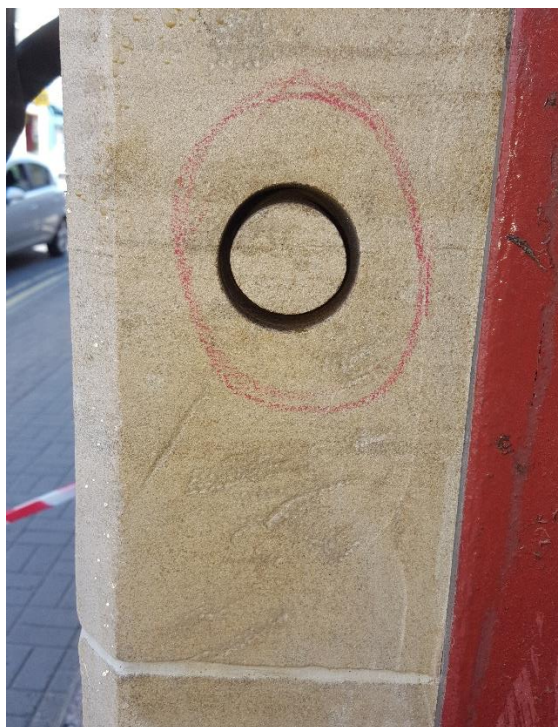
Plate 1. Image of the cored sandstone before removal from the building. This area was representative of sample 4-type sandstone and was cored from a section of the stone that wasn't directly street facing.

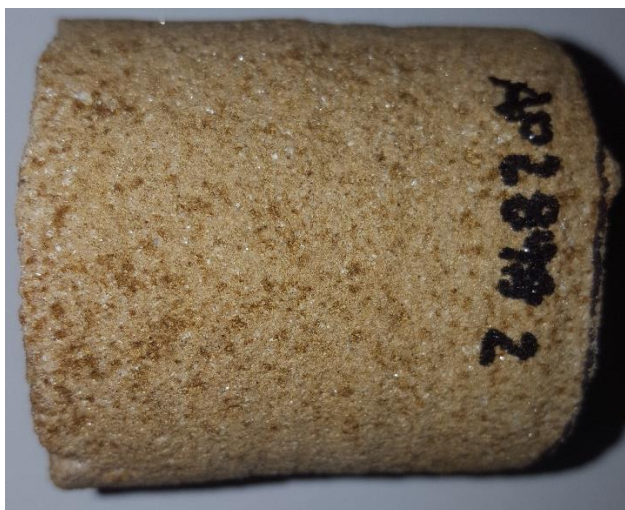
Plate 2. Side view of the sandstone core post thin section preparation. The thin section was cut parallel to the length of the core.

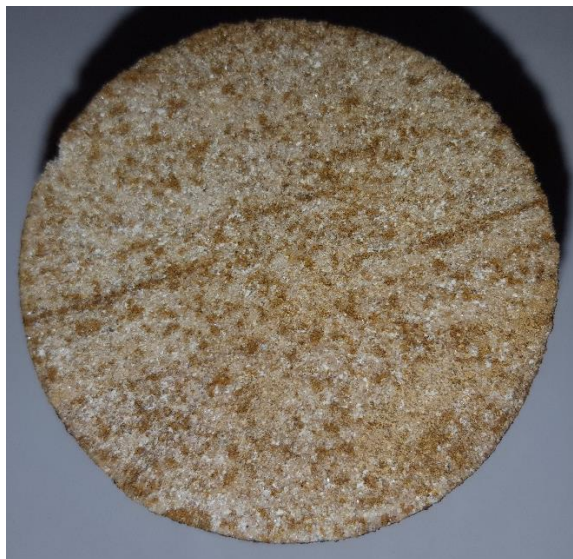
Plate 3. End view of the sandstone core post thin section preparation. Distinct Fe-oxide and clay mottling is present, while slight bedding alignment is visible towards the centre of the core. The alignment of narrow and discontinuous layers indicates that the stone was edge bedded within the building; a common observation throughout most buildings in Cupar.

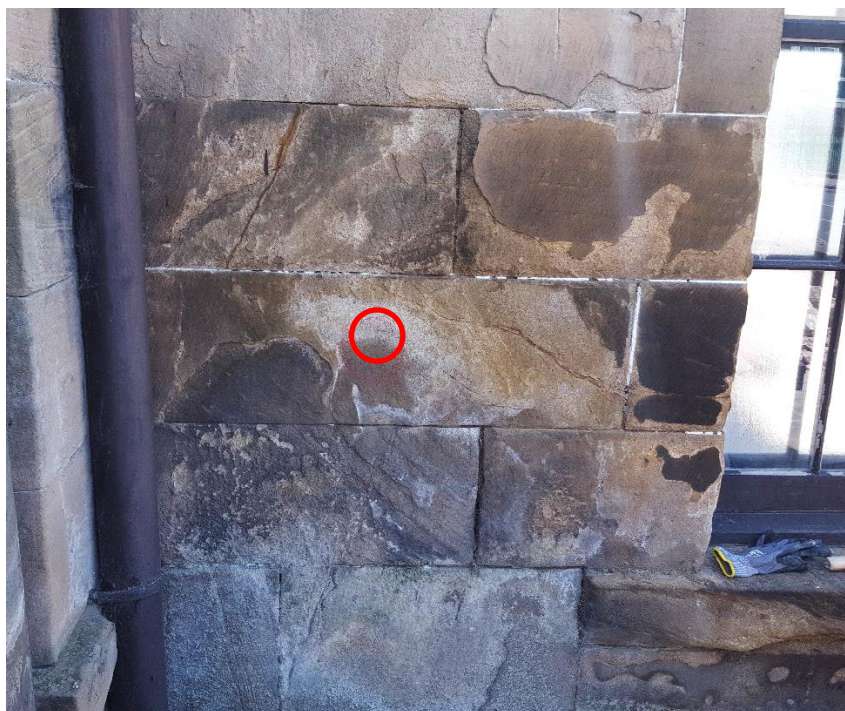
Plate 1. The sandstone sample was cored from the area highlighted by the red circle. This area was representative of sample 1-type sandstone and was cored from a section of the building not obviously noticeable from the seated area in front of the building.

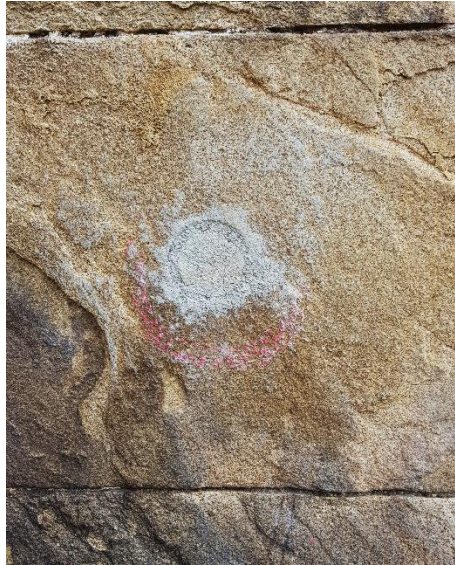
Plate 2. View of the backfilled cored area of the stone.

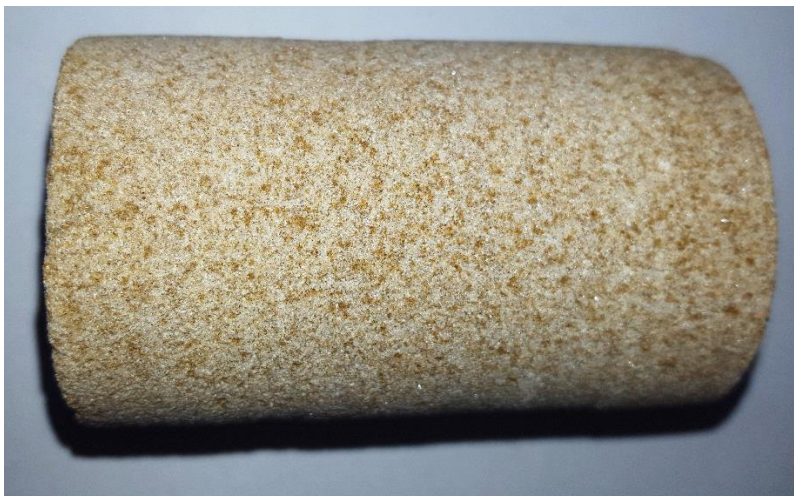
Plate 3. Side view of the sandstone core post thin section preparation. The thin section was cut parallel to the length of the core.

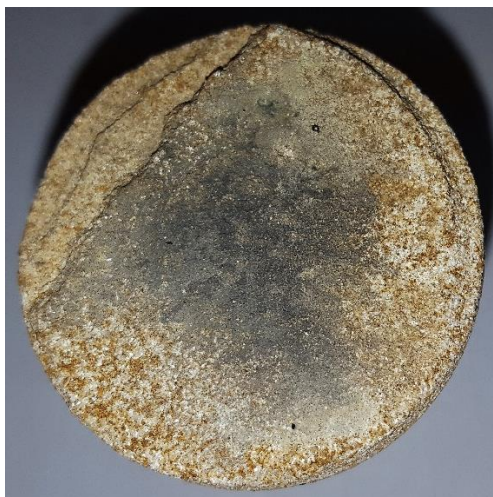
Plate 4. End view of the sandstone core post thin section preparation. A dark discoloured surface crust is evident on the exposed weathered surface of the core. The area from where the stone was cored had suffered from delamination, with the presence of salt efflorescence on the stone surface.

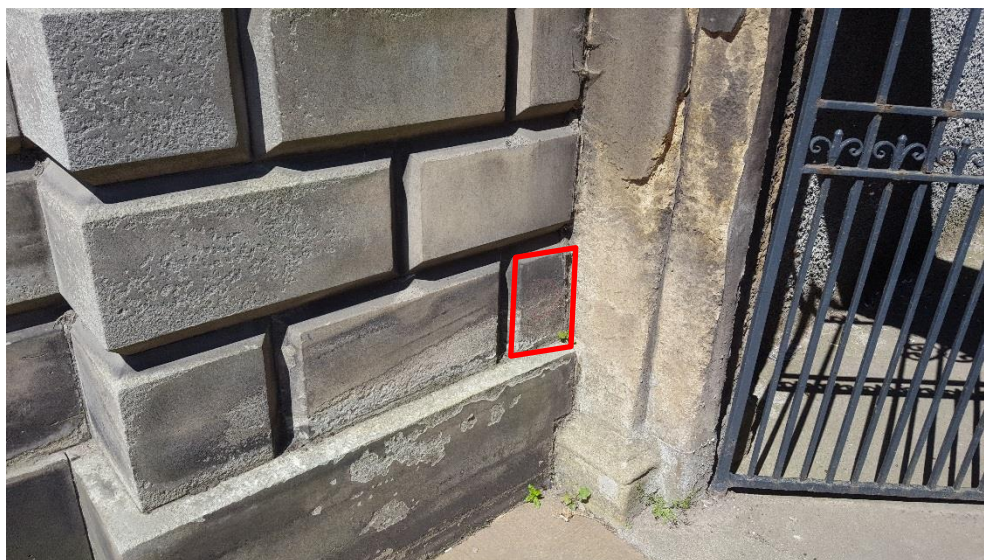
Plate 1. The sandstone sample was cored from the area highlighted by the red box. This area had suffered very slight surface scaling decay and was located in an inconspicuous area of the building that won't affect its aesthetic value.

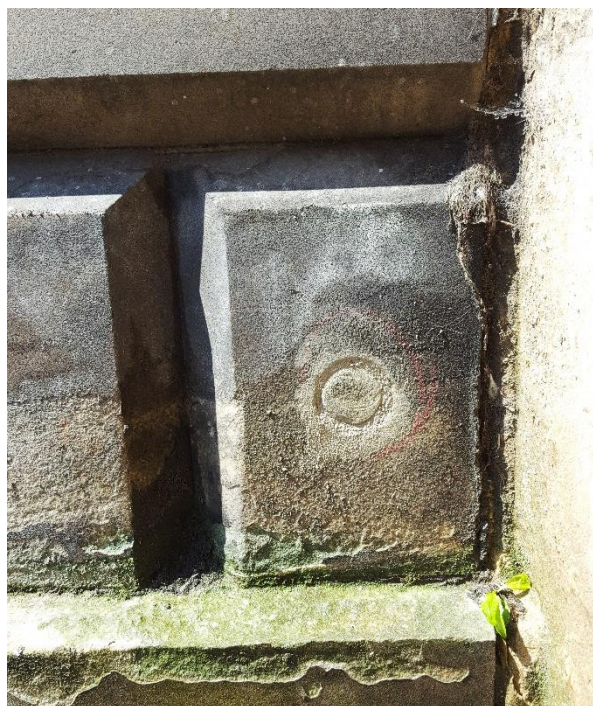
Plate 2. View of the backfilled cored area of the stone. The mortar used for backfilling provides a similar surface colour to the stone.

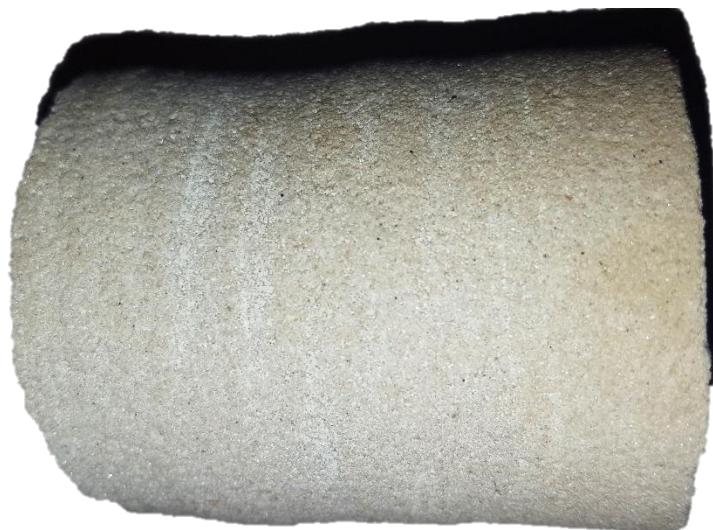
Plate 3. Side view of the cored section of sandstone post thin section preparation. There are no visible textural features evident in hand specimen.

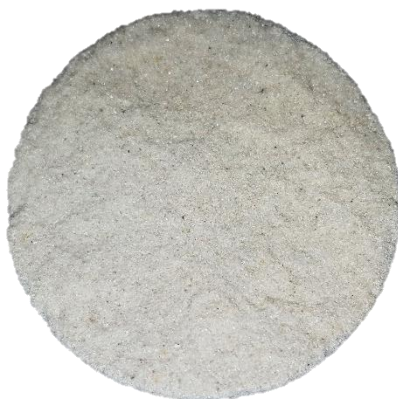
Plate 4. End view of the sandstone core post thin section preparation.
