SCOTTISH
LIME CENTRE
TRUST

REPORT ON MORTAR ANALYSIS BY X-RAY DIFFRACTION (XRD)

AP 3480
Inverkeithing Town House
Inverkeithing Stone and Slate
Audit

SITE	Inverkeithing Town Hall, Inverkeithing Stone and Slate Audit
CLIENT	Fife Historic Buildings Trust
DATE SAMPLE RECEIVED	11/12/2019
ANALYSIS DATES	11/12/2019 – 28/03/2020
ANALYSIS, INTERPRETATION & REPORT BY	Dr Katie Strang and Roz Artis
CLIENT REQUIREMENTS	Mortar Analysis by X-ray diffraction
STRUCTURE DATE	1770
STRUCTURE TYPE	Town Townhouse
MORTAR DATING	Original?
LOCATION/ FUNCTION IN BUILDING	Mortar taken at 1.2m height at rear elevation
CONDITION OF SAMPLE RECEIVED	The sample received consisted of a bag containing intact piece of mortar plus fines Size of largest piece = 137.85mm x 87.12mm x 65.14mm Total mass of sample received = 129.33 grams

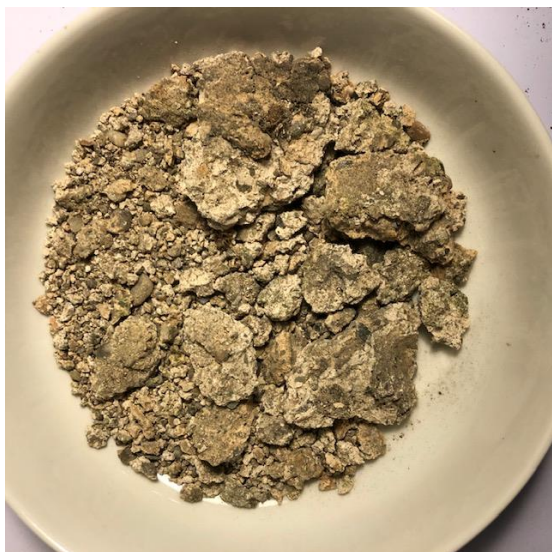
Plate 1. Image showing the condition of the sample, as received. Tray diameter c160mm.

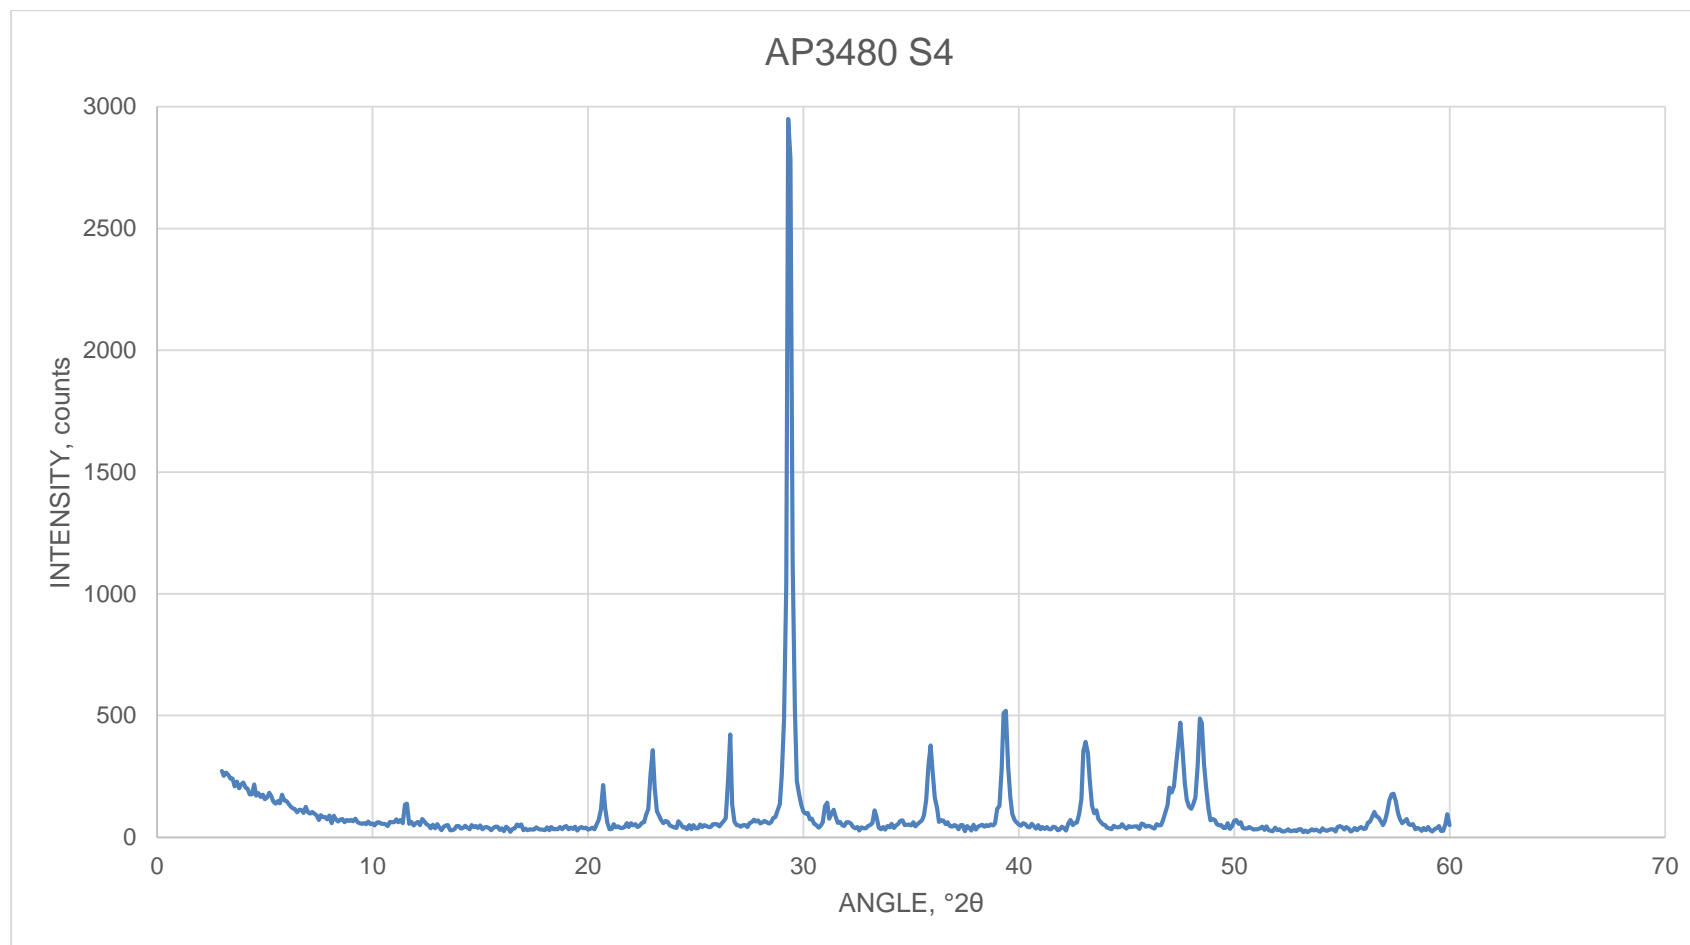
Figure No. 1: Harling from Inverkeithing Town Hall, Rear elevation

The results of the analyses are shown in the following figure, in the form of a labelled X-ray diffractogram:

The abbreviations used on the chart, to identify peak positions, are as follows:

cc = Calcite (CaCO_3) calcium carbonate, carbonated binder from lime type binders,

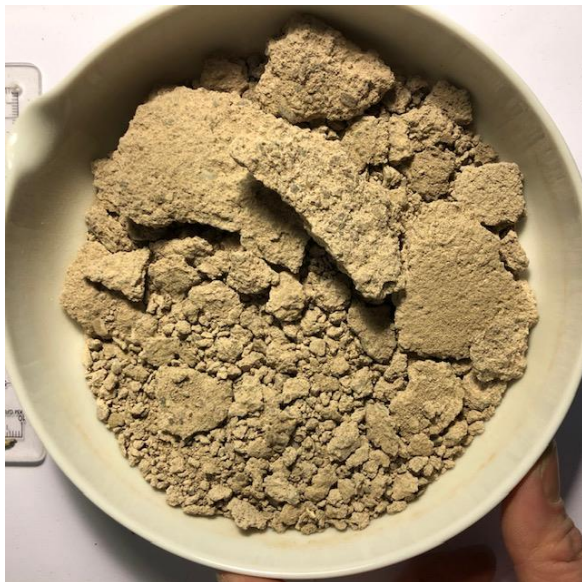
Plate 1. Image showing the condition of the sample, as received. Tray diameter c160mm.

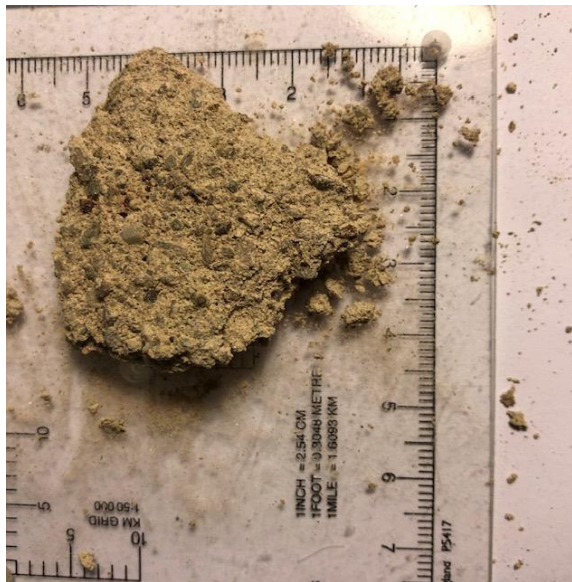
Plate 2. Image showing a fresh face of the mortar. Scale is in mm.

PROCEDURE	OBSERVATIONS
PRELIMINARY VISUAL ANALYSIS OF SAMPLE	<p>The mortar was found to be friable and weak and it could be broken under light finger pressure. Once broken it could be powdered further with ease. The phenolphthalein indicator test confirmed that the mortar was fully carbonated whilst a water droplet test confirmed that the mortar was porous as the droplets were rapidly absorbed and the water diffused throughout the mortar. There was no evidence of burnt fuel/coal fragments or shell aggregate in this sample.</p> <p>The harling appeared to only consist of one coat and varied between 2.15mm to 5.47mm in thickness.</p>
EXAMINATION OF PREPARED SAMPLE BY BINOCULAR MICROSCOPE (X40 MAGNIFICATION)	<p>Lime inclusions were not observed, however, there were small powdery inclusions indicative of leaching or sulphate attack. Aggregates are dominated by quartz with quartzite, granite and indeterminate lithic fragments present, they are angular to elongate in shape and up to 5.2mm in size.</p> <p>The mortar is heavily voided, with the majority of voids containing linings of calcite as a secondary product, soiling and organic matter, all indicating that water percolation through the mortar had occurred, resulting in leaching, and the re-precipitation, of binder components and the deposition of transported debris.</p>

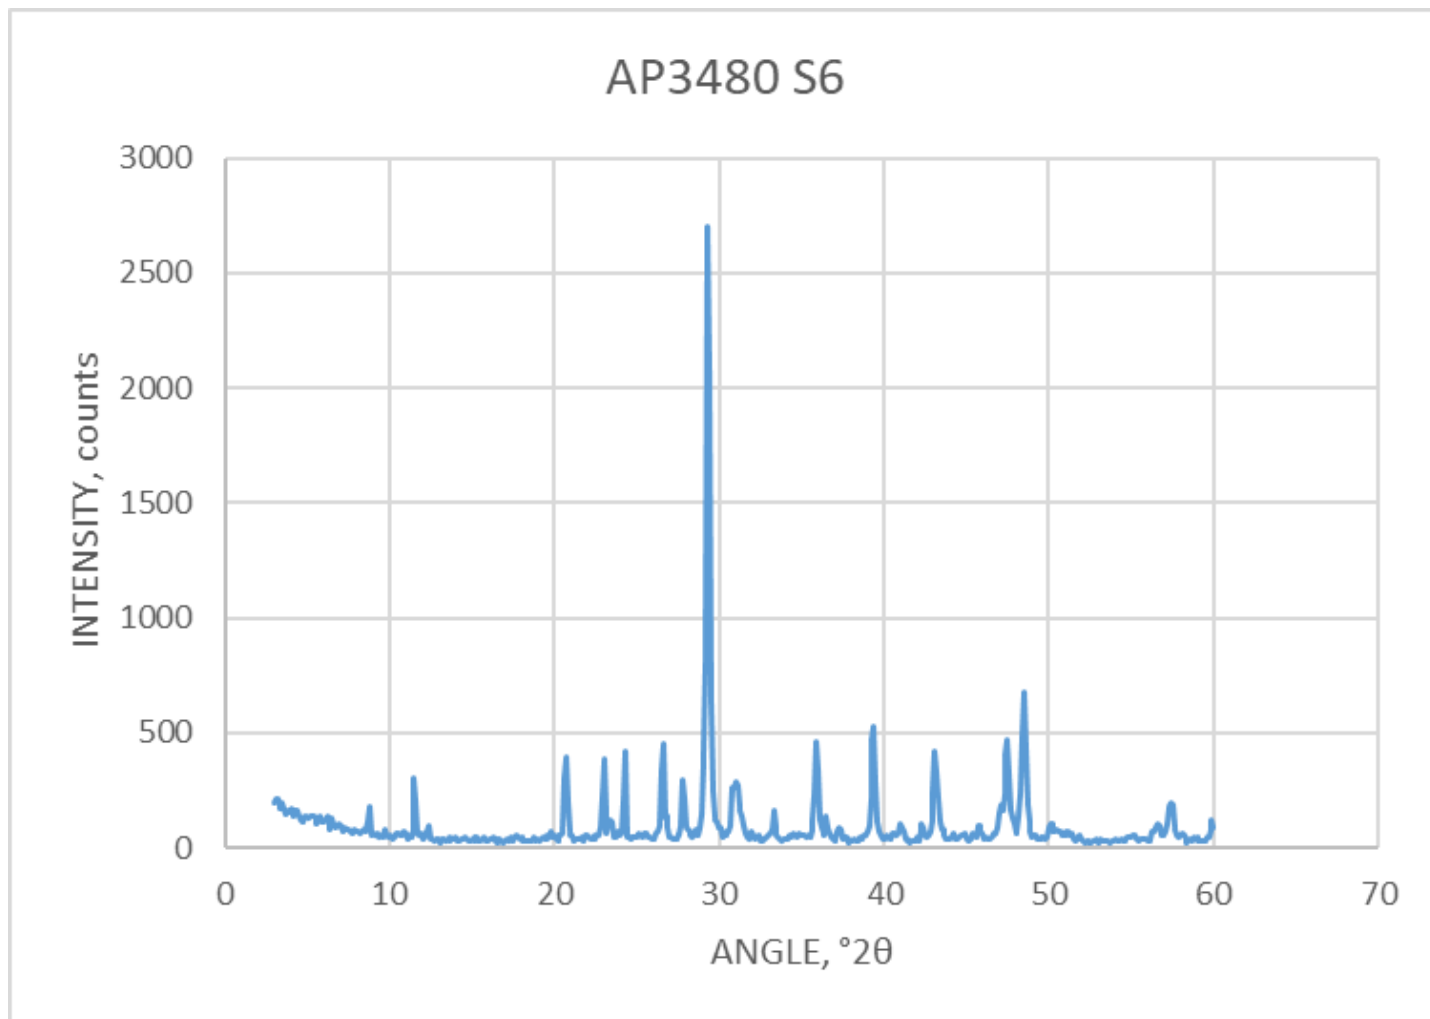
Figure No. 1: Harling from Cadora Café

On the basis of the results from the XRD analysis, it is indicated that the mortar analysed had been mixed from a well graded sand and a non-hydraulic lime binder, most likely prepared as a 'dry hydrate'. The XRD shows a particularly high gypsum content, which is likely present as a reaction product between atmospheric pollution (possibly acid rain or sulphates from combustion deposits) and lime from the mortar. There was some friability and fabric disruption observed in the samples .

The results of the analyses are shown in the following figure, in the form of a labelled X-ray diffractogram:

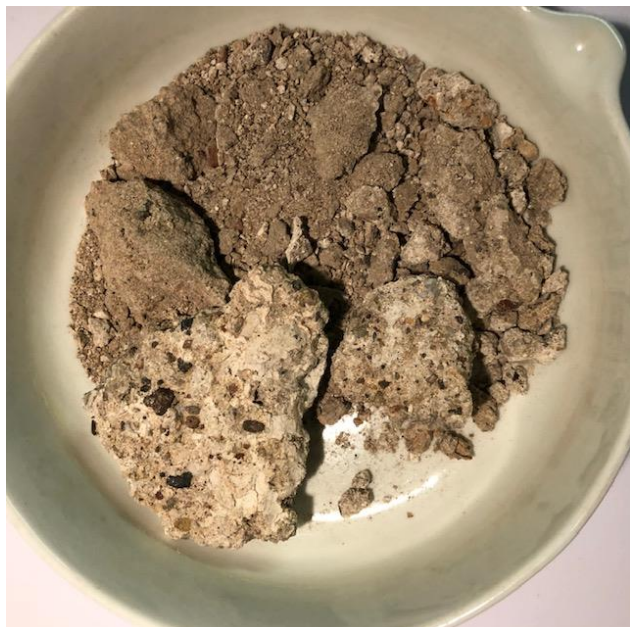
Plate 1. Image showing the condition of the sample, as received
Dish c160mm diameter.

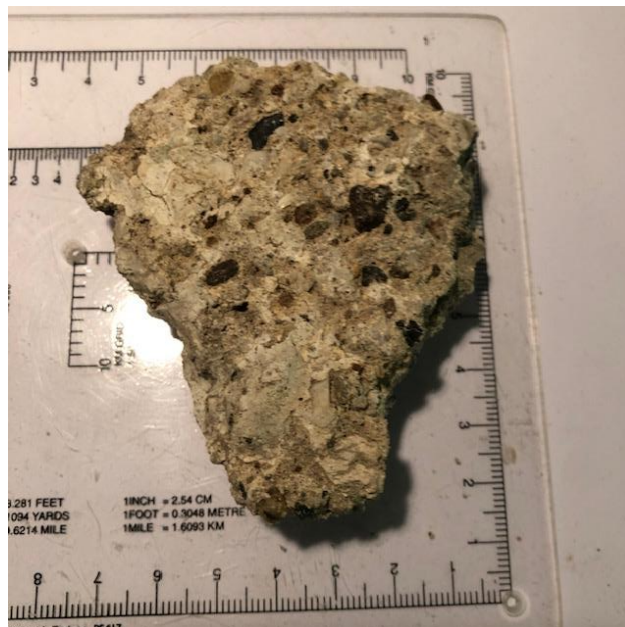
Plate 2. Image showing the surface of the mortar; note lime
inclusions and coal fragments can be observed. Scale is in
mm.

PROCEDURE	OBSERVATIONS
PRELIMINARY VISUAL ANALYSIS OF SAMPLE	<p>The harling was found to be moderately hard and it could be broken under light to moderate finger pressure. Once broken it could be powdered further with ease. The phenolphthalein indicator test confirmed that the mortar was fully carbonated whilst a water droplet test confirmed that the mortar was porous as the droplets were rapidly absorbed and the water diffused throughout the mortar. Lime inclusions were observed, and these were sub-round to sub-angular in shape and up to 3.6mm in size. The inclusions had the appearance of a putty lime or quicklime in hand specimen. Aggregates are dominated by quartz, lithic fragments and shell fragments, aggregates tend to be angular to elongate in shape and up to 4.2mm in size. The intact pieces of mortar, although heavily voided appeared to have been reasonably well compacted, when placed. The mortar contained an abundance of air voids, some of which contained linings of calcite as secondary products, soiling and organic matter, all indicating that water percolation through the mortar had occurred, resulting in leaching, and the re-precipitation, of binder components and the deposition of transported debris.</p>

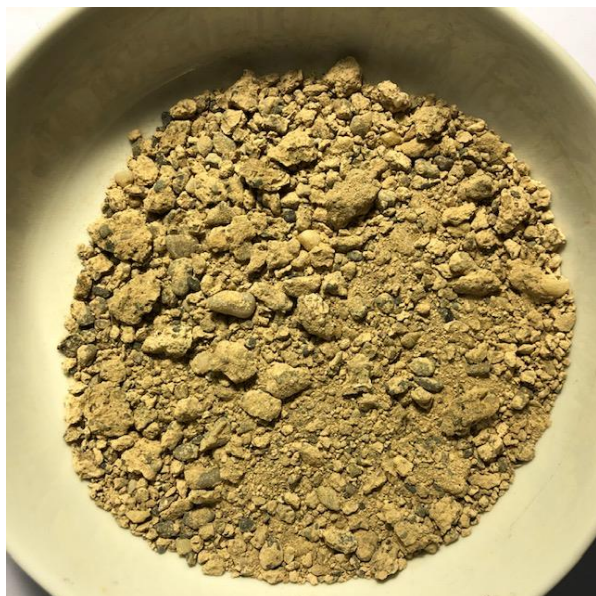
Plate 1. The total sample received (dish c.160mm diameter).

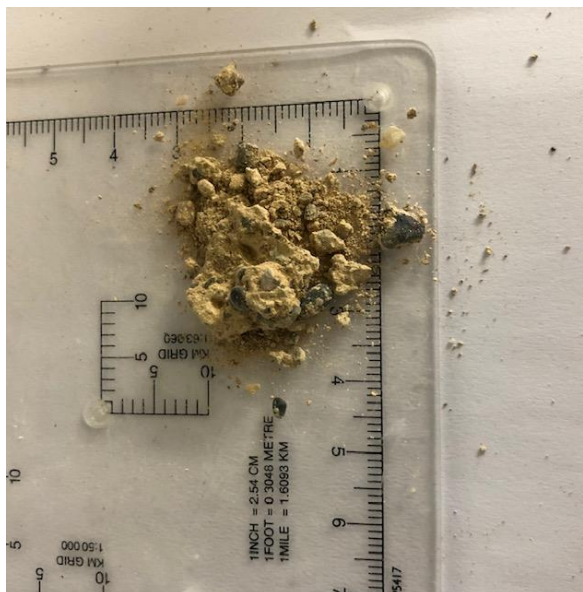
Plate 2. Showing a fragment of disrupted mortar. Scale is in mm.

PROCEDURE	OBSERVATIONS
PRELIMINARY VISUAL ANALYSIS OF SAMPLE	The sample was received as a fully carbonated disrupted mortar. The mortar was very friable and easy to disrupt, and could be powdered with ease. Fines consisted of silt and individual aggregate grains. There was no evidence of lime inclusions or burnt fuel/coal fragments in this sample. The phenolphthalein indicator test confirmed that the mortar was fully carbonated whilst a water droplet test confirmed that the mortar was porous as the droplets were rapidly absorbed and the water diffused throughout the mortar.
EXAMINATION OF PREPARED SAMPLE BY BINOCULAR MICROSCOPE (X40 MAGNIFICATION)	The colour of the mortar assessed against the Munsell Soil Colour Charts was found to be to 10YR 8/1 'white' to 10YR 8/2 'very pale brown'. The surface of the intact appeared porous and had a granular texture, contained an abundance of air voids, some of which contained linings of calcite as secondary products, soiling and organic matter, all indicating that water percolation through the mortar had occurred. Overall the aggregate appears quite coarse grained, with larger well weathered and grey/dark in lithic fragments appear to make up the courser aggregate fractions. The finer fractions of aggregate appear to consist mainly of sub-angular to angular quartz grains with a buff/orange/grey tint.

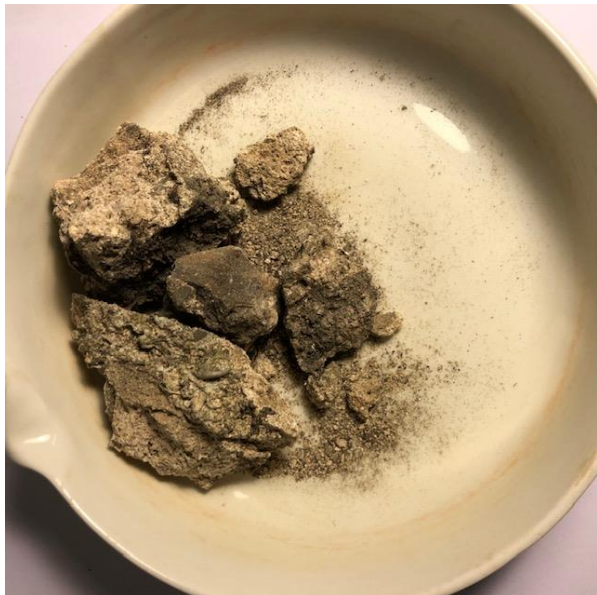
Plate 1. The total sample received (dish c.160mm diameter).

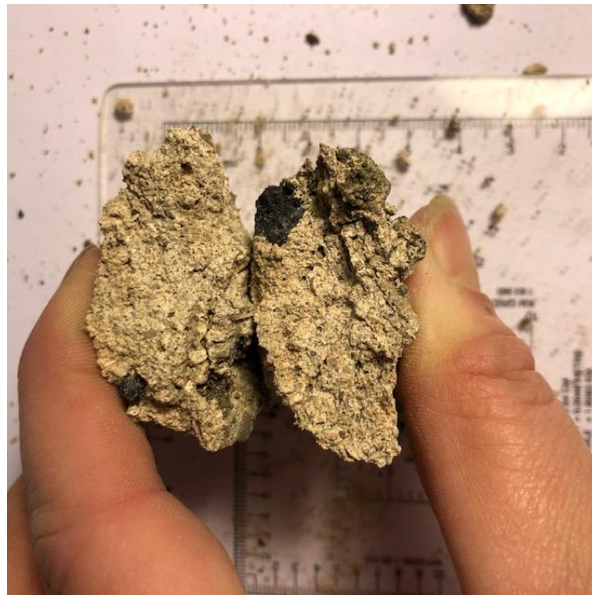
Plate 2. Showing a fragment of disrupted mortar. Scale is in mm.

PROCEDURE	OBSERVATIONS
PRELIMINARY VISUAL ANALYSIS OF SAMPLE	The sample was received as a fully carbonated intact piece of mortar plus fines. The sample is weak and requires little pressure to disrupt, and is easy to powder. There were large irregularly shaped, cracked lime inclusions throughout the sample. There was also an abundance of large angular coal fragments throughout. The phenolphthalein indicator test confirmed that the mortar was fully carbonated whilst a water droplet test confirmed that the mortar was porous as the droplets were rapidly absorbed and the water diffused throughout the mortar.
EXAMINATION OF PREPARED SAMPLE BY BINOCULAR MICROSCOPE (X40 MAGNIFICATION)	The colour of the mortar assessed against the Munsell Soil Colour Charts was found to be 10YR 8/2 'very pale brown'. The surface of the sample appeared porous and had a granular texture and the mortar appeared binder rich. Larger lithic fragments appear to make up the courser aggregate fractions, and are well weathered and the majority are igneous or sedimentary in origin. The finer fractions of aggregate appear to consist mainly of sub-angular to angular quartz grains with a buff/orange/grey tint. The mortar showed voiding and evidence of calcite re-precipitation, suggesting moisture movement through the mortar.

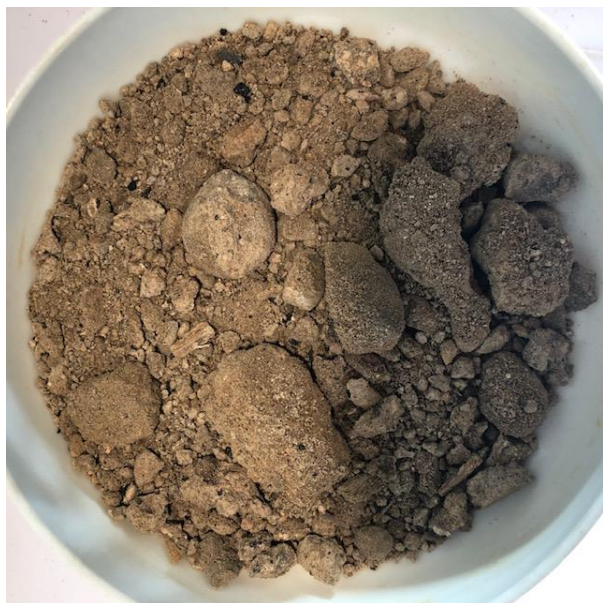
Plate 1. The total sample received (dish c.160mm diameter).

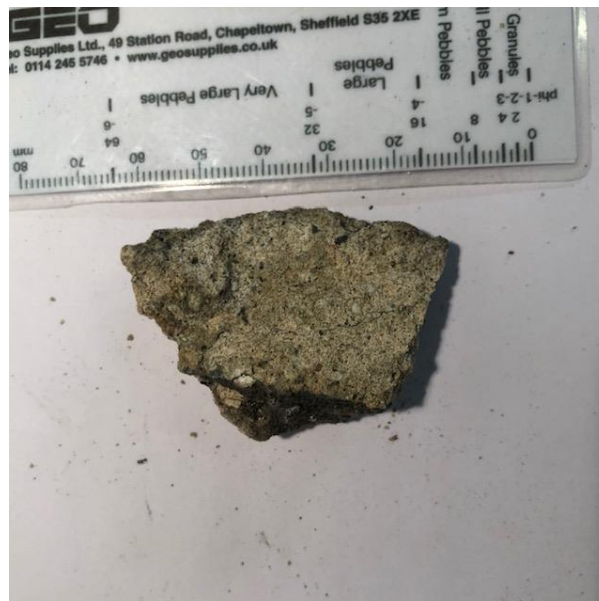
Plate 2. Showing a fresh face of the mortar. Scale is in mm.

PROCEDURE	OBSERVATIONS
PRELIMINARY VISUAL ANALYSIS OF SAMPLE	The sample was received as a fully carbonated intact piece of mortar plus fines. The sample is firm and requires significant pressure to disrupt, however once disrupted it is easy to powder. There are frequent, small (<2mm) irregularly shaped, cracked lime inclusions throughout the sample. Some inclusions were hard and appeared to contain relic cores (i.e the source limestone had not completely burnt through). There was a small proportion of burnt wood and coal fragments throughout the sample. The phenolphthalein indicator test confirmed that the mortar was fully carbonated whilst a water droplet test confirmed that the mortar was porous as the droplets were rapidly absorbed and the water diffused throughout the mortar.
EXAMINATION OF PREPARED SAMPLE BY BINOCULAR MICROSCOPE (X40 MAGNIFICATION)	The colour of the mortar assessed against the Munsell Soil Colour Charts was found to be 10YR 8/2 'very pale brown'. The surface of the sample appeared porous and had a granular texture and the mortar appeared binder rich. Overall the aggregate appears relatively fine grained with buff/orange/grey coloured sub-angular to angular quartz grains dominating the mineralogy. The mortar showed voiding and evidence of calcite re-precipitation – particularly towards the outer surface. The combination of this, along with vegetation growth and soiling, indicates significant moisture movement through the mortar.
