Inverkeithing Town House Standing Building Survey

Project ID: 023

Data Structure Report

May 2020

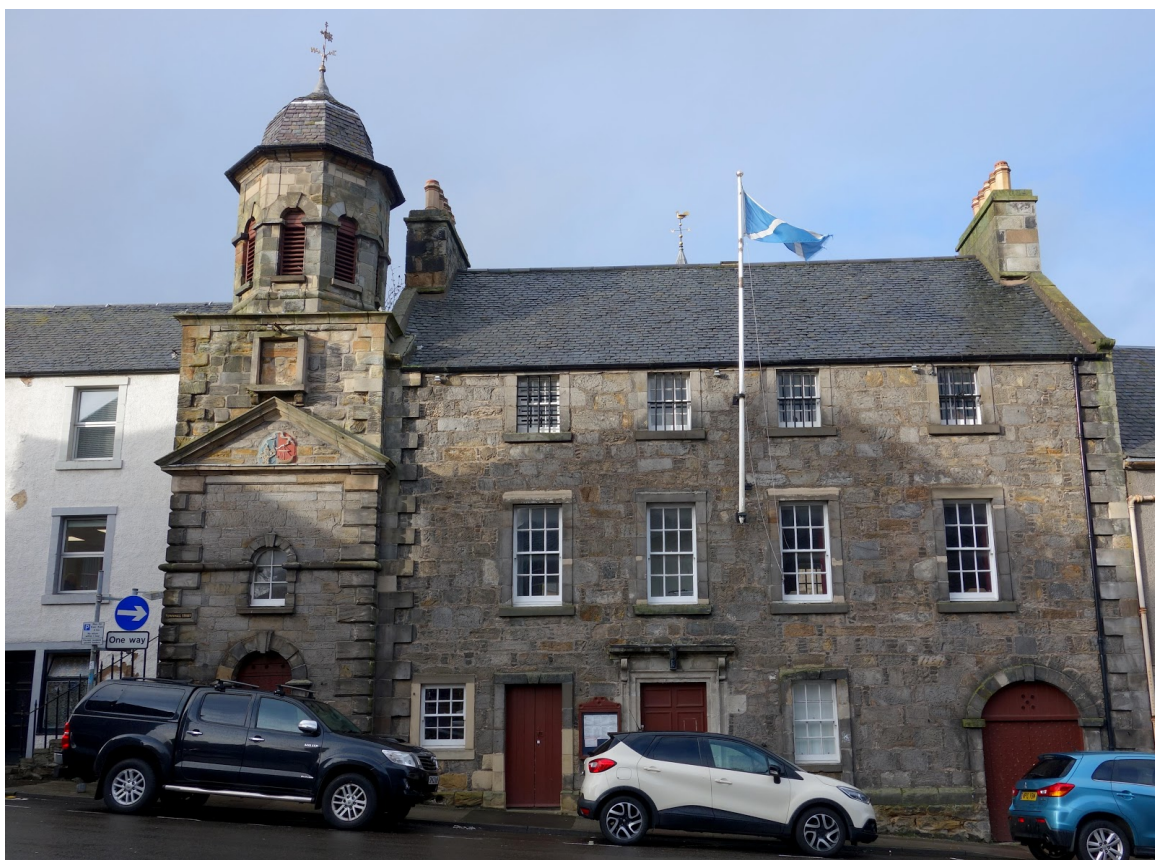
The front, south, facing elevation of the Town House (Illus. 4 & 5) is, perhaps not surprisingly given it would have been the public facing side, the most decorative and includes sophisticated masonry techniques, decorative caulking and patterns of diagonal chiselling. Variations in chisel marks between some blocks likely indicate areas of repair.

Illustration 4: Front, south facing, elevation of Town House.

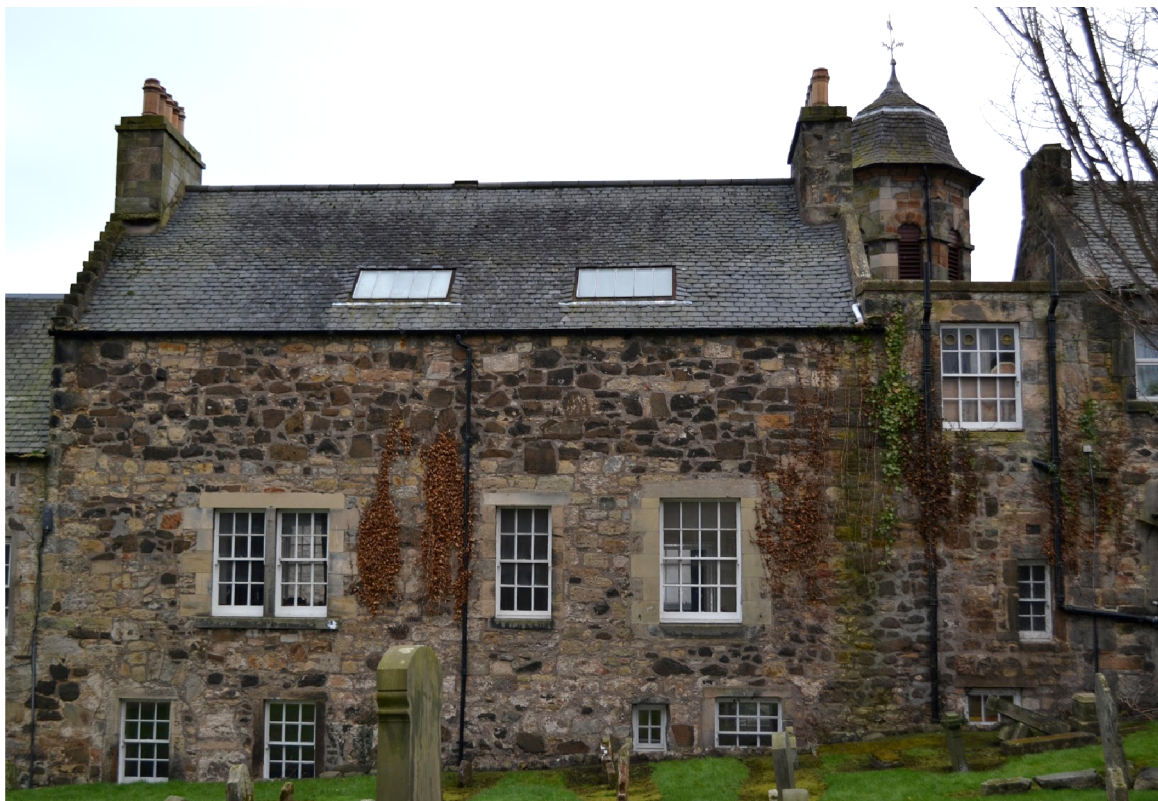
The rear elevation backs on to a graveyard, the ground level of which sits considerably higher than the base of the Town House (Illus. 6 & 7). It was not uncommon for the ground level height within popular graveyards to be increased during the 19th century. Rapid increases in population within industrial areas led to graveyards running out of space and increasing the ground level height provided a solution.

Illustration 6: Rear, north facing, elevation of Town House.

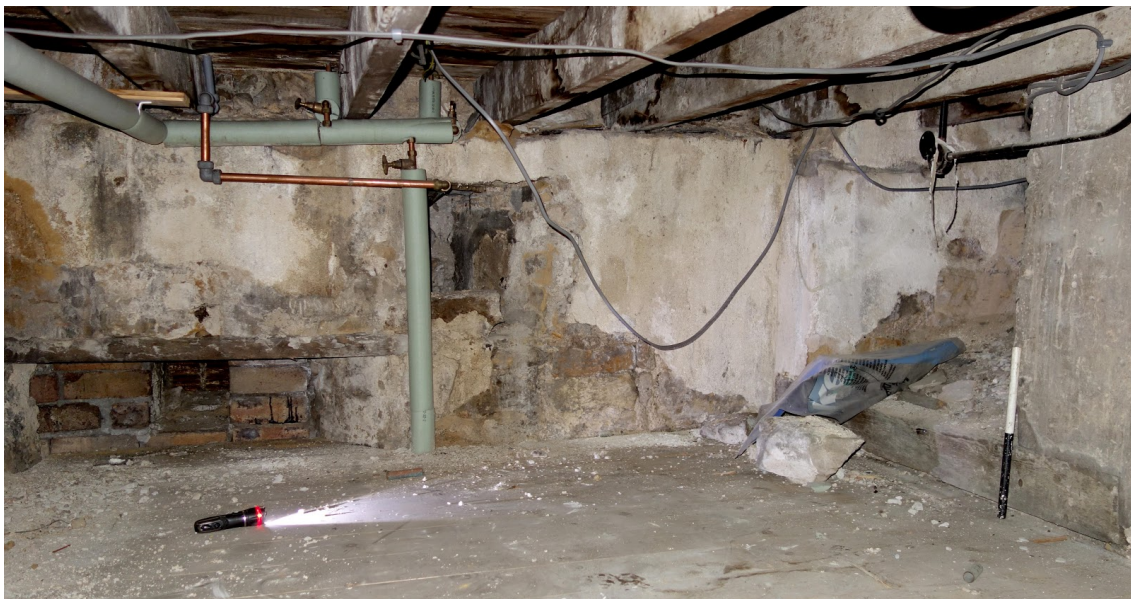
The top of a bricked up window and possible blocked slit window are present in the northern wall (Illus. 9) corresponding to the location of the same on the exterior rear elevation (Illus. 7). Only the top 0.3 m of the window was visible above floor level which measured 1.1 m wide tapering out to brickwork blocking the former opening. A modern vent sits beneath a wooden interior lintel.

Approximately 0.1 m above the top eastern corner of the blocked window lies the possible blocked slit window. It measures approximately 0.5 m in height and 0.47 m in width on the internal wall edge, tapering to a narrower gap some 0.15 m in width at the outer wall edge. A modern copper overflow pipe runs through the top of the slit window.

At the northeastern corner of the room, on the eastern wall, an 0.9 m wide opening with a large wooden beam at its base holds five to six disturbed stone stairs (Illus. 9) which appear to have led to the current floor level of Room 1.

Illustration 9: Northern wall of Room 5b showing blocked window, slit window and stairs in northeastern corner (scale = 0.2 m divisions).

Clyde Archaeology would recommend further monitoring and recording is undertaken during refurbishment works particularly during the removal of internal wall coverings, floors and ceilings. These recommendations are provided for guidance only. Final decisions on the requirement for future work in relation to refurbishment of the Town House rests with the planning authority and Historic Environment Scotland.

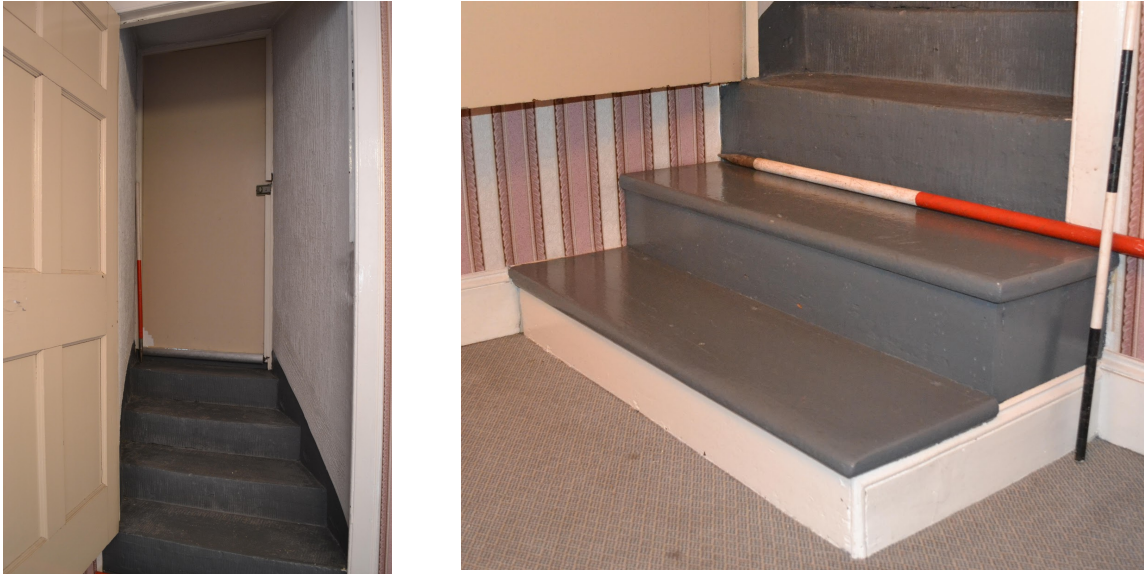
A series of stone stairs run between the western stairwell (Room 5) and Room 7 (Illus. 5 & 8). They comprise four stone steps within Room 7, which has doors at either end, which lead down to two wooden steps that extend into Room 6, required due to the floor level of this room being much lower than the bottom of the stone stairs (Illus. 10). The stone steps are painted but regular chisel/machine marks can be seen on the surface and edges of steps. They extend through the width of the tower wall (Area 1) and the main block (Area 2) at a distinct angle (Illus. 10). The reason for this angle and lack of correspondence with the floor level of Room 6 is unclear but is likely due to various elements belonging to different phases of build and use.

Illustration 10: Angled stone stairs of Room 7 (left) and wooden stairs extending into Room 6 (right) (red/white scale = 0.5 m divisions, B&W scale = 0.2 m divisions).

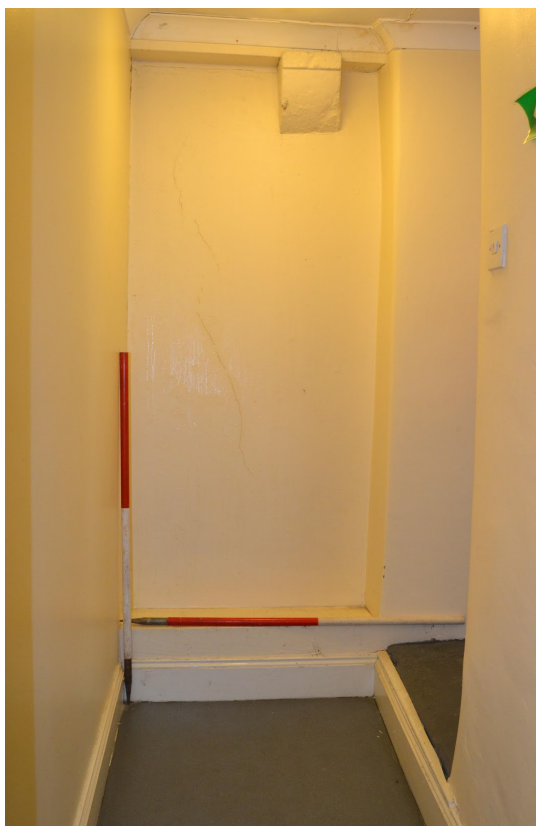
This room is accessed from Room 8 down two stone stairs as a result of the floor level of Room 9 being 0.4 m lower than Room 8. The lower stair is wide (c. 0.9 m). The corridor may have been punched through the original outer wall of the main block. The possible remains of an iron hinge protrudes from the northern wall behind the door to Room 8. A wooden ceiling beam at the northern end of the main north to south running room is tied into eastern stone wall of the main block (Area 2) and continues into Room 11. The eastern end of the beam on the northern side of the room rests on a stone corbel which unusually projects inwards (Illus. 11). An additional machined wooden beam sits just above floor level on northern side and is also keyed into eastern stone wall.

Illustration 11: Stone corbel at northern end of Room 9 (red/white scale = 0.5 m division).

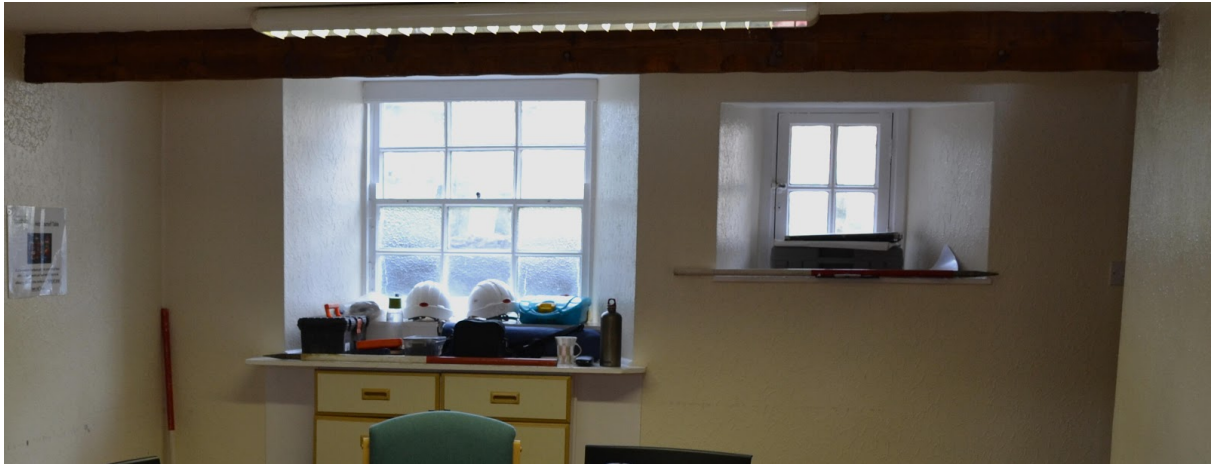
Four modern wooden beams span east to west across a lowered ceiling. Two recessed sash windows are present on the northern wall with the easternmost being much smaller (Illus. 12). The proximity of the small window to the adjacent larger window suggests they could belong to different phases or a former layout. The door in the western wall leading to Room 23 is very low.

Illustration 12: Windows in the northern wall of Room 16 (red/white scale = 0.5 m division).

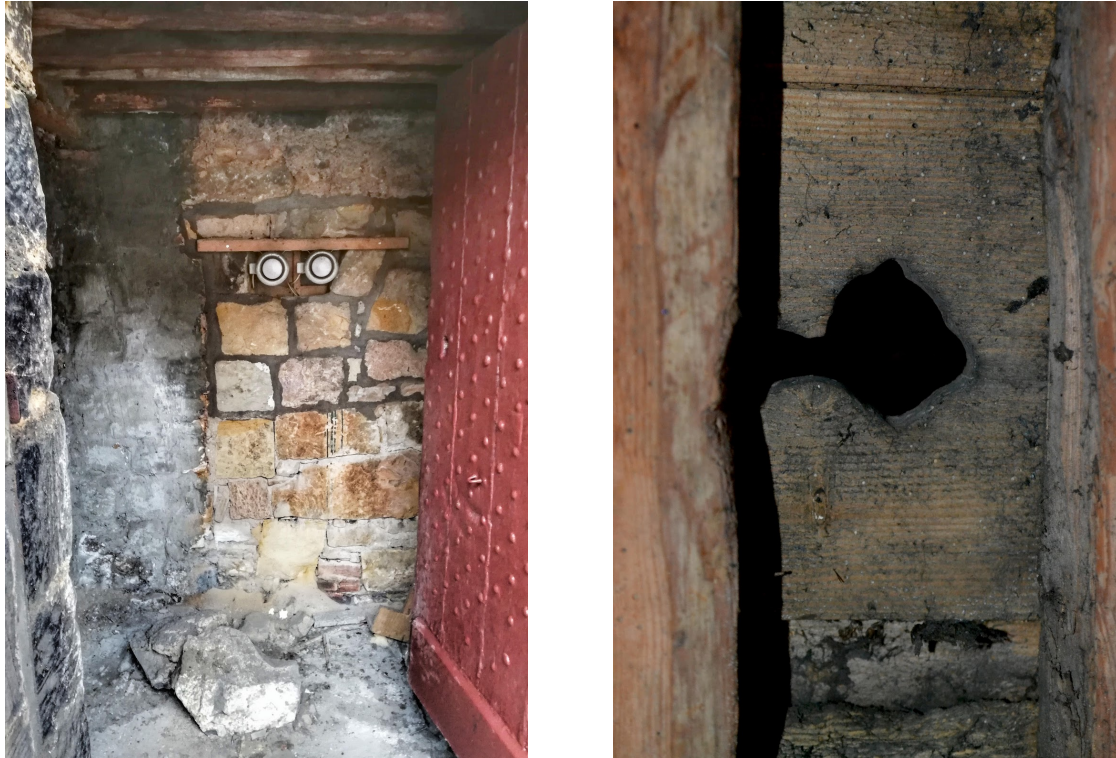
A small room accessed off the main street via a wood panelled door with decorative studs on the outside (Door D). A single stone step leads down from street level onto a rough earth/debris floor. A large opening is present on the northern wall now blocked with sandstone (Illus. 8 & 13) and containing two vents from Room 24 to the north. Clearly chamfered vertical stonework is present on the eastern side of the blocked opening indicating the presence of a formal edge to the now blocked up opening/doorway. Some of the closely spaced old wooden beams on the ceiling hold possible carpenters marks. Two holes are present in the ceiling boards. The central hole is distinctly worn into a rough 'club' shape (Illus. 13) and likely represents a bell rope opening.

Illustration 13: Blocked opening in Room 20 (left) and bell rope opening (right).

The recess in the southern wall represents the opposite side of the blocked opening seen on the northern wall of Room 20 (Illus. 8 & 13), but is partially obscured by floor cabinets.

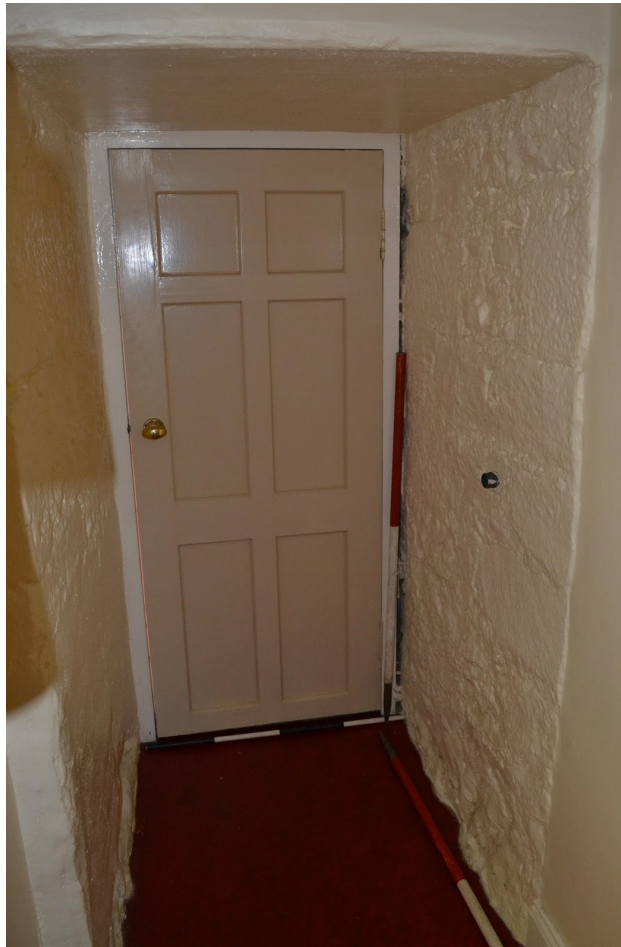
The floor level of the corridor leading from Room 16 is slightly lower than that of Room 16 and the northern and southern sides of the corridor closest to Room 16 are clearly constructed of dressed stone (Illus. 14) where it runs through the wall of the Main Block (Area 2). This suggests the corridor may be an original feature and could relate to the pre-18th century tolbooth. Areas at the base of the northern corridor wall show signs of erosion/wear. The aperture of the corridor is wider at the western end than the eastern and steps out on the northern side where a partition wall has been added as part of Room 22.

Illustration 14: Corridor leading from Room 16 with dressed stone on northern & southern walls (red/white scale = 0.5 m divisions, B&W scale = 0.2 m divisions).
