**NORTHLIGHT HERITAGE**  
REPORT: 6  
PROJECT ID: 10  
DATA STRUCTURE REPORT

**Friary Gardens Community Dig**  
**Inverkeithing**  
**Fife**

Data Structure Report

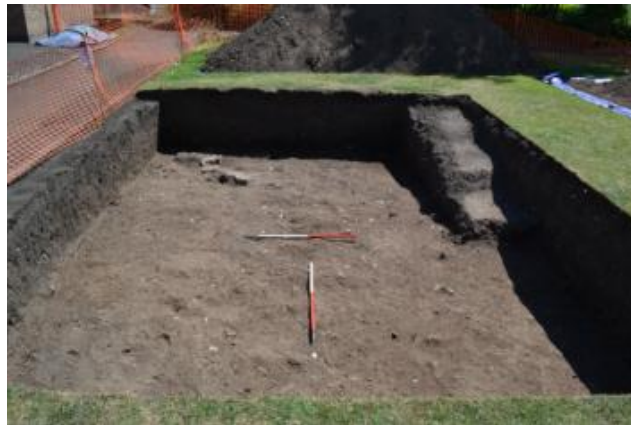
Illus. 4; Trench 5 Photo after excavation of (009 & 032).

Trench 5 measured c. 6.00 m north-west to south-east by c. 4.70 m north-east to south-west (Illus 4 & 5). Following the hand removal of turf and topsoil, due to the depth of known overburden deposits these were excavated with a mini-digger under archaeological supervision. The overburden comprised a mixed layer of dark brown sandy silt with frequent lenses of yellowish gravelly sand (009) and below which greyish mid brown clay silt (032), together measuring up to 0.90 m in depth. Following machine excavation of 032, the lines of possible wall tops could readily be observed (011) and (020). This included the southern long wall (011) and another portion of possible wall (020) extending to the south-west.

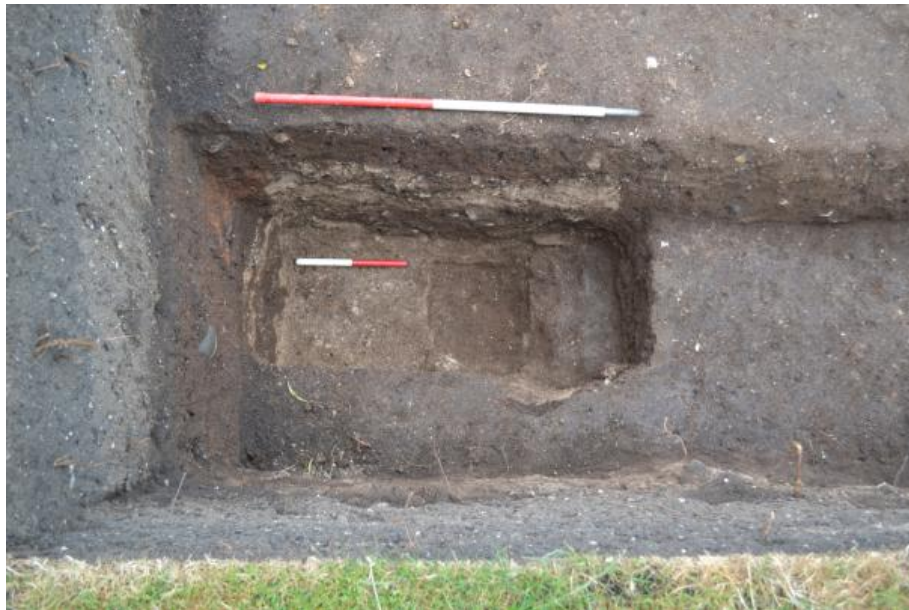
Illus. 5; Trench 5 Post-Excavation northern part slot 1, showing 015, 016 and 035.

Slot 1, measured 4.70 m by 1.00 m and 0.10 and investigated a concentration of yellowish mortar on the surface (015) and characterise (010) in this part of the trench. The mortar (015) formed a 1.10 m north-east to south-west wide band and appeared to represent where the long wall (011) had been robbed. To the north of 015, was distinct reddish orange deposit (016), while to the south of 010 extended.

Further excavation revealed 015 sat within a linear cut [034], up to 0.45 m deep, and comprised several layers of mortar and mid brown sand silt. At the base there was another linear cut [033], visible on the southern side, upto 0.12 m deep, and appeared to relate to the original foundation depth. To the south of the cut [033] was a compact surface (035), of dark brown sand silt, with moderate gravel inclusions, but it was unexcavated. One flat stone sat in the section that could be suggestive of disturbed paving, but insufficient area was observed to assess with confidence.

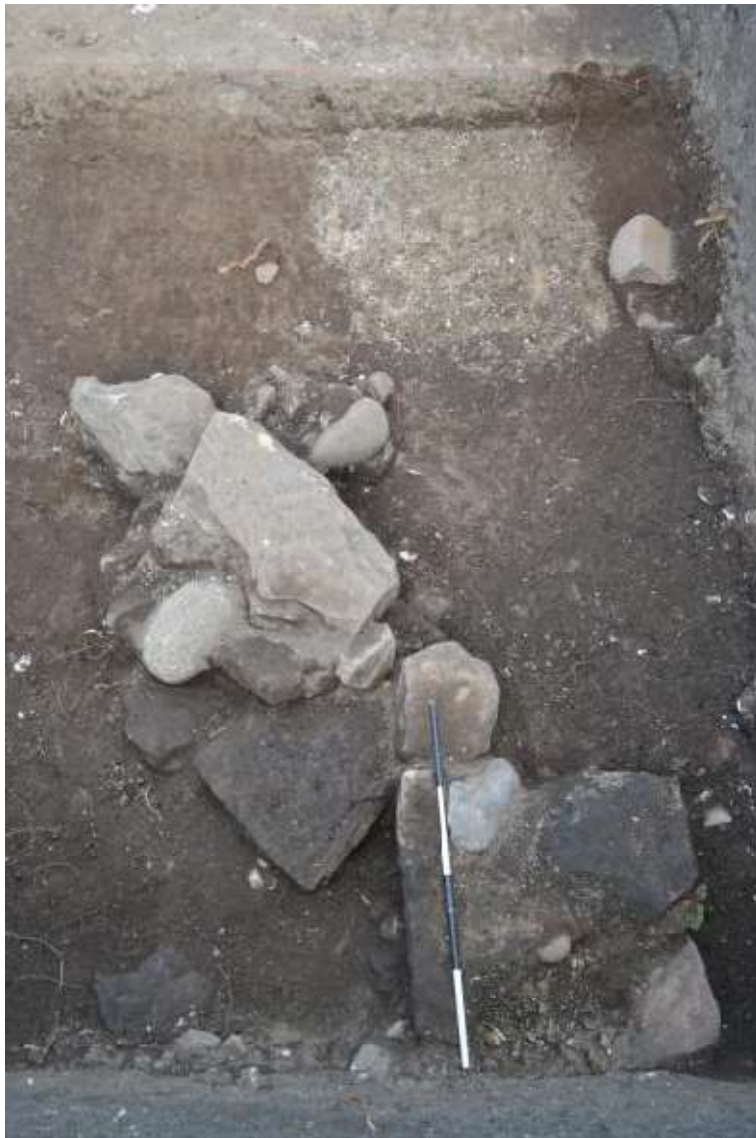
Illus. 6; Trench 5 slot 2 mid-excavation showing 011, 014 and 020.

The possible wall (011, 020) tops were partially covered by a layer of (010) (Illus 6). Layer (010) extended across the trench and comprised a blackish mid brown sandy silt, up to 0.45 m in depth, with frequent oyster shells, broken animal bones and sherds of ceramic. Further excavation then focussed on two areas of the trench, slot 1 and 2.

This revealed that the remains of the long wall [011] were 0.67 m wide and extended c. 0.65 m into the trench, with a ragged western end, where it had been robbed. Set up against the wall [011] was a more irregular pile of stones (020), upto 0.50 m at five 'course' deep. During excavation it could be seen that deposit (010) was present between the stones, suggesting it formed when the stones were standing exposed and / or they sank into the deposit (010). The stone pile (020) appeared also partially sealed by (019), a deposit of mid brown silt clay, which sat up against the south face of wall [011].

In the north east corner of slot another wall face [021] was revealed to be present, running at right angles to [011], and appearing to be keyed together. Excavation was then restricted to a smaller area on northern side of the wall [011], measuring 0.30 m by 0.60 m. This revealed beneath (010) an orangish mid brown clay silt (022) upto 0.18 m in depth, with frequent inclusion of daub, and moderate inclusions of charcoal, occasional sherds of ceramic and animal bones, to be present. Below (022) was mid to dark brown clay silt (027) upto c 0.20 m in depth. Below (027) was a deposit of sub-angular stone with yellowish mortar matrix (028) and although unexcavated had the appearance of a rubble layer.

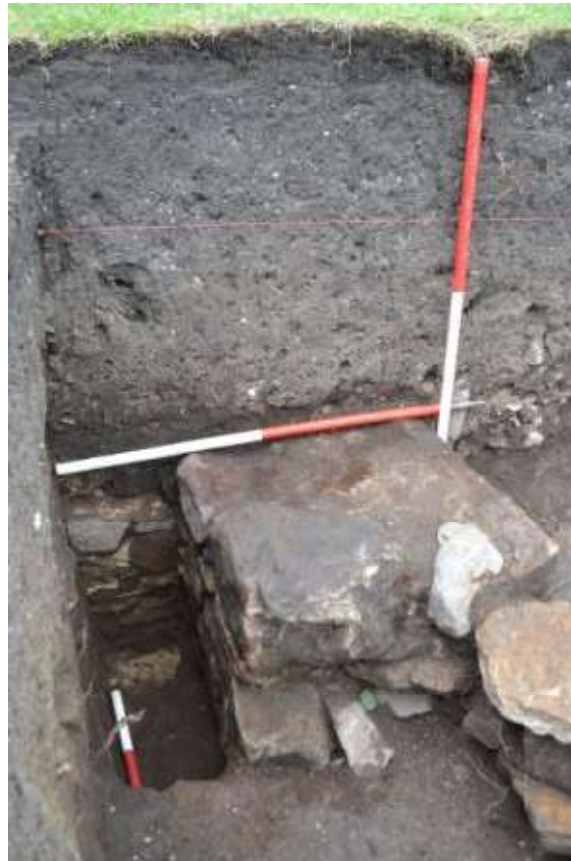
Illus. 9; Detail of internal wall [021] and long wall [011].

It was also revealed wall [011] to a surviving depth of 0.79 m, over seven courses, and wall [021] to a surviving depth of 0.57 m, over seven courses, and established both extended deeper.

With the discovery of a cross wall [021] it was possible to establish that the interior of the building sat to the north, as expected, but perhaps more importantly that it extended much deeper than the limit of excavation. Indeed, the presence of a stone and mortar deposit (028) at the lowest level suggests that the building had

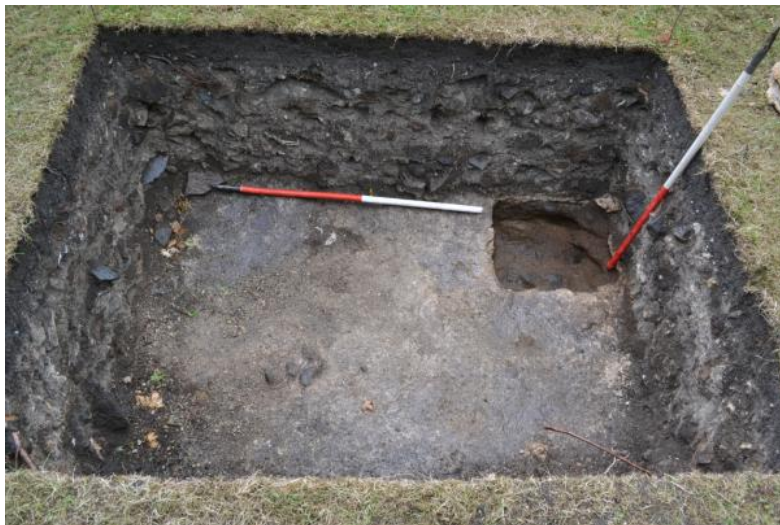
Illus. 12; Trench 8 Photo of mortar surface and north-east facing section.

Deposit 004 sealed a layer of brown friable silt (013) between 0.03 and 0.06 m in depth. Below 013 was a compact mottled white / grey / brown mortar (024) deposit which extended across the trench. In one corner of the trench a flat stone was present which could represent remains of robbed out paving sat on the mortar (024) but insufficient in extent was seen to assess confidently. Where excavated (024) had a depth of 0.01 to 0.03 m and revealed a deposit of flat angular stone fragments with a compacted brown silt gravel matrix (025) below. Excavation revealed (025) had a depth of up to 0.03 m and sat on what appeared to be bedrock.

The main deposit in trench 8, comprised a layer of stones (004) whose character was the same as those comprising the remains of the barrel vaulted cellar within which the trench was located. However the stones were much smaller than those forming the construction of the cellar and had more of an appearance of smaller rubble left behind when larger stones were removed. It can be suggested 004 relates to the consolidation of the cellar in the 1930' when the friary garden was redeveloped as a green space for the community. The stone deposit sat on a thin layer of darker brown silt (013), which may potentially the last remnants of in-situ archaeological deposits, most likely relating to later phases of use of the cellar, or could relate to trampled / in washed deposits following clearance of roof collapse during the 1930's works. The mortar deposit had the

appearance of a floor surface, and while it could have been laid down as part of the 1930's works, may actually be the remains of an original medieval floor surface.

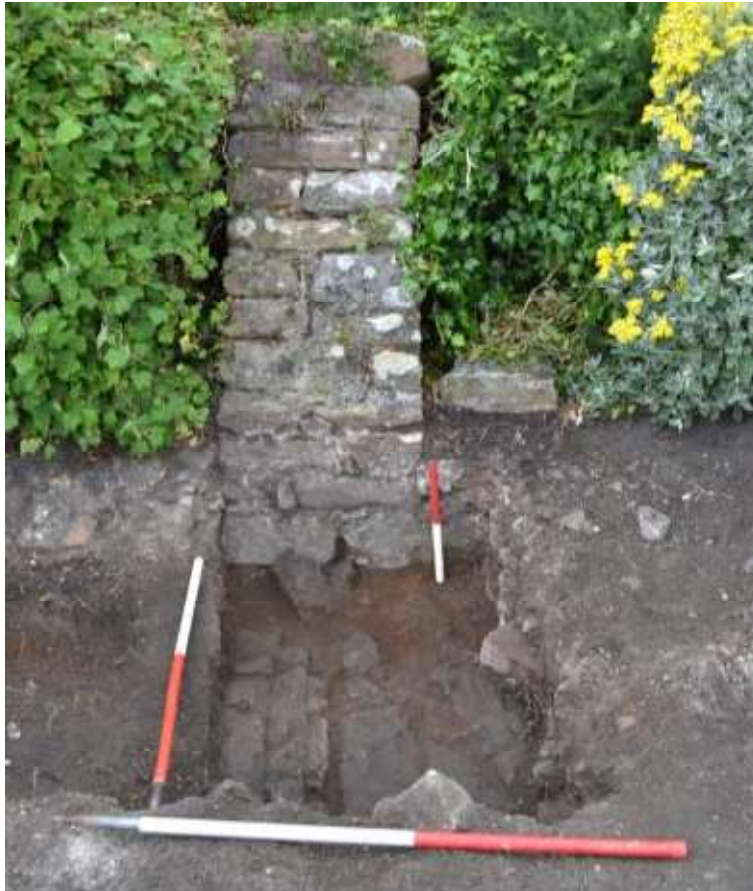
Illus. 15; Trench 9 Photo of buttress (030) and rock-cut channel (031).

Excavation of 012, revealed it had a depth of upto 0.20 m deep, below which was shattered / weathered bedrock. It also established that the buttress (030) had survived to a height of 1.70 m, c 0.50 of which were below the current ground level, by 0.60 m and extending west to the wall for 1.10 m. It was also established that the buttress sat directly on the bedrock but in a shallow cut (029), c 0.04 m deep into the rock, which had been prepared before its construction. To the south of the buttress was a linear shallow rock cut channel (031), upto 0.34 m wide and upto 0.09 m deep, which extended 0.85 m east into the baulk, suggesting it extended further.

Placed to characterise the buttress (030), results of excavation in trench 9 suggest as it sat directly on bed rock (029) in a prepared cut and extended to a depth of 0.50 below current ground level, that it may relate to phase of construction relating to the use and reuse of the friary. If it had been added, for example in the 1930's 'restoration' of the friary gardens as a more 'decorative feature' it is probable that the ground would not have been prepared to such an extent prior to construction. If authentic it would also indicate that the eastern extent of friary buildings were of sufficient height to require some form of support with the increasingly steep slope towards the shoreline. The shallow rock cut channel to the east of the buttress, was probably created to help drainage from the building, again suggesting these features were part of an overall 'building design'. The layer of mortar and stone (008) was similar in character to that encountered in trench 8 and may relate to the clearing and consolidation of rooms during the 1930's works.
