Inverkeithing Friary, Fife

Standing Building Survey

Project ID: 023

Data Structure Report

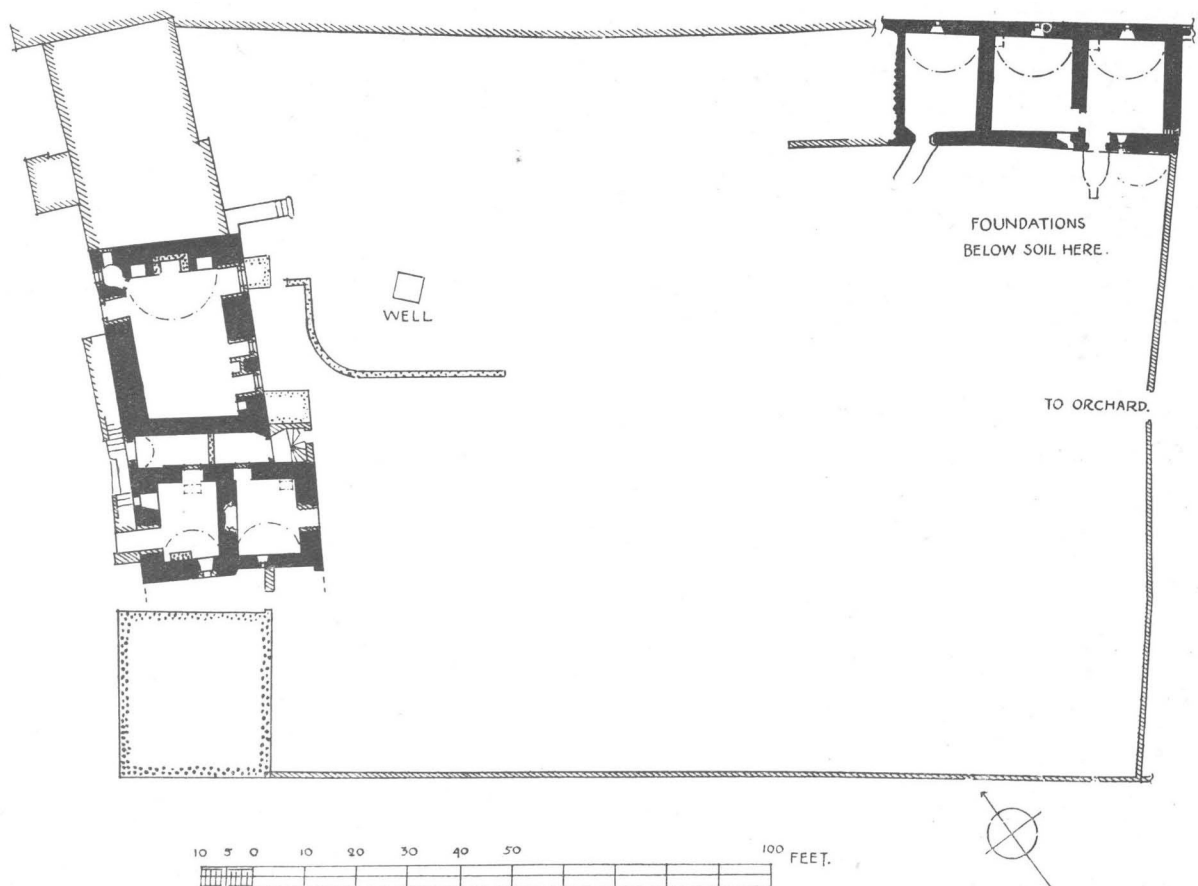
Illustration 2: Plan of the Hospitium recorded by the RCAHMS (1933, p153)

The RCAHMS survey records the layout prior to the renovation works in the later 1930s when the council converted the building for public use (Illus. 2). During this work doorways and windows were blocked and remodelled and lean-tos on the eastern wall demolished.

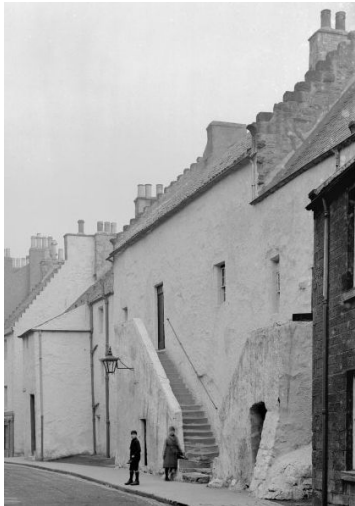
Illustration 3: Western frontage prior to refurbishment in the 1930s. Taken c.1920, Canmore Image SC01106557

These clearly show the change in the eastern and western elevations that resulted from the 1930s renovations (Illus. 3-7), including the reinstatement of at least one gothic lancet window above the ground floor door on the western elevation (Illus. 4 & 5), removal of the southernmost stairway on the same elevation (Illus. 4 & 5) and the significant remodelling of the windows and doors on the eastern elevation (Illus. 6 & 7).

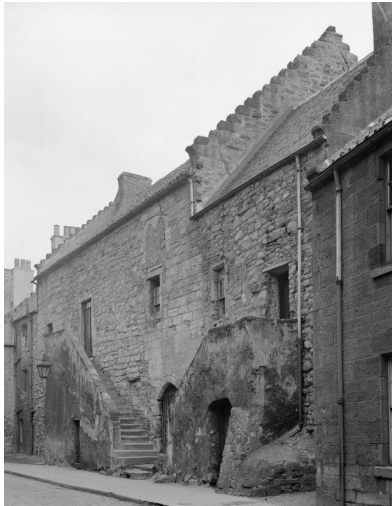
Illustration 4: Western frontage during refurbishment. Taken approx. 1934, Canmore Image SC395193

Above three possible notches (54) an older gothic lancet double window (70) was reinstated during refurbishment in the 1930s (Illus. 4 & 5). A lintel-like stone sat immediately above these windows and may have formed part of a low course of projecting stone (53) at the top of the wall.

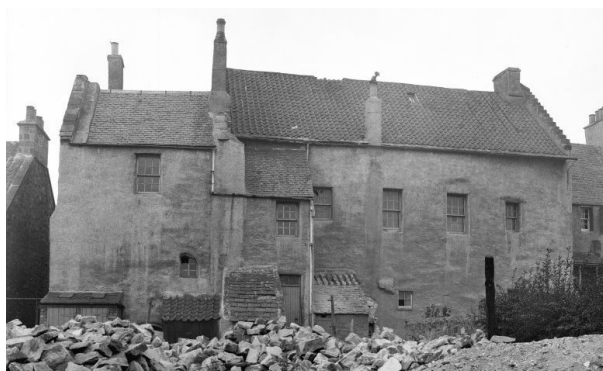
Illustration 6: Eastern elevation prior to the refurbishment in the 1930s. Taken c. 1933. Canmore Image SC395188

The lower arched window (22) in Area 3 seems to have been reinstated or remodelled as the window in this position shown on an earlier photograph is much smaller (Illus. 6 & 7). A faint suggestion of a blocked doorway (21) was recorded just below and to the left of this window. Projecting stonework (19) could suggest another building once sat on this side while the chimney above (7) was added during the renovations in the 1930s.

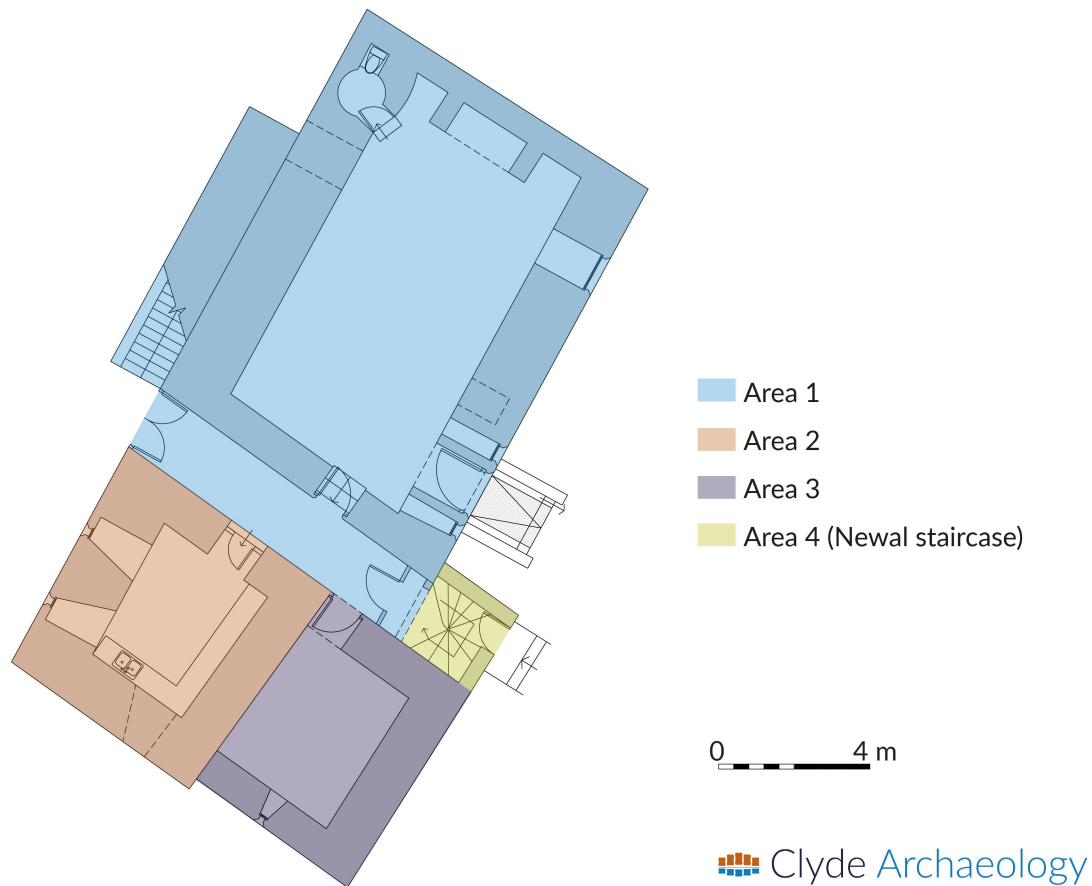
Illustration 8: Survey Areas

The Friary Hospitium comprised a double storey long rectangular structure with a complex history. For the purposes of this survey the structure was divided into four areas that broadly correspond to possible different buildings (Illus. 8).

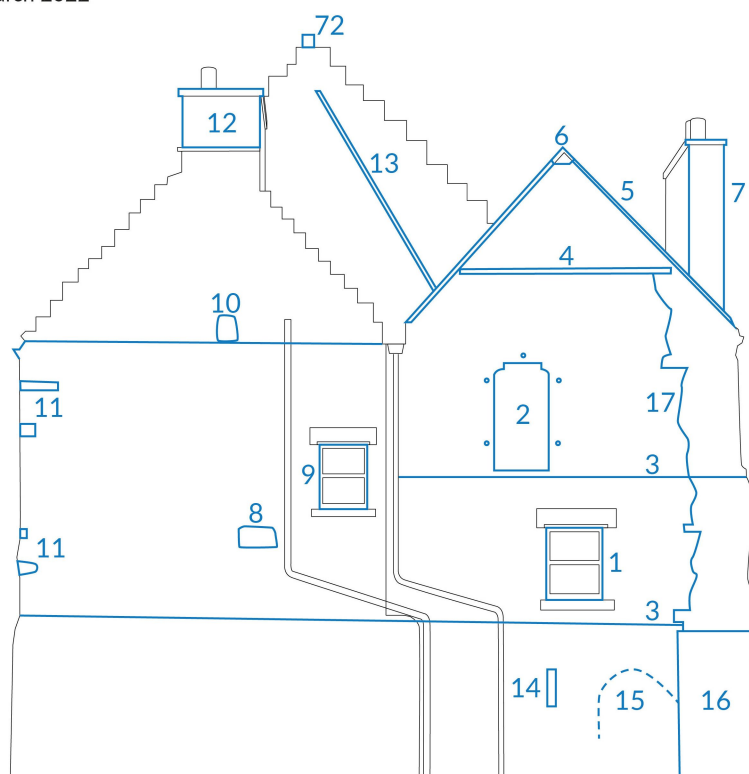
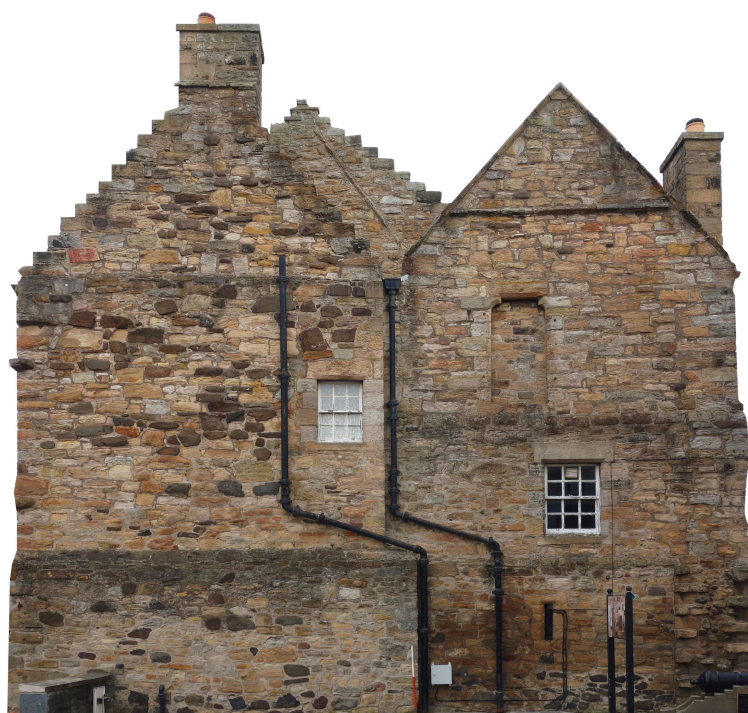
Illustration 9: South facing elevation (not to scale)

The south facing elevation (Illus. 9) was formed from the southern walls of Area 2 and 3. The top of the southern gable of Area 1 was also visible. Although the southern walls of Areas 2 and 3 appeared on the same alignment the wall of Area 3 was set back slightly (Illus. 8). Two windows (**1 & 9**) were likely inserted when the buildings were renovated in the 1930s while a slit window on the ground floor of Area 3 (**14**) was likely older. The blocked window or door (**2**) is of unknown date.

The rooflines of the two buildings differ, with Area 2 having a crow step and offset chimney (**12**) while Area 3 had a Cavetto moulding in the cove (**5**) and a carved apex stone (**6**). The roof behind the gable of Area 2 was also lower than the roofline of the gable.

Horizontal lines of projecting stones (3) possibly represent the floor lines of buildings to the south while an upper string course (4) on Area 3 is of unknown purpose. Two possible small blocked apertures (10 & 8) were present on the gable of Area 2 while projecting stones (11 & 16) show buildings continued in this direction, although it is also possible these stones were a 1930s insertion to indicate other buildings existed here.

A former roofline visible on the gable of Area 1 (13) was formed from flat copes. It is of unknown date and does not appear to match either of the two similar features noted on the northern gable (Illus. 11, 40 & 41). A possible base for a stone finial was present at the apex (72).

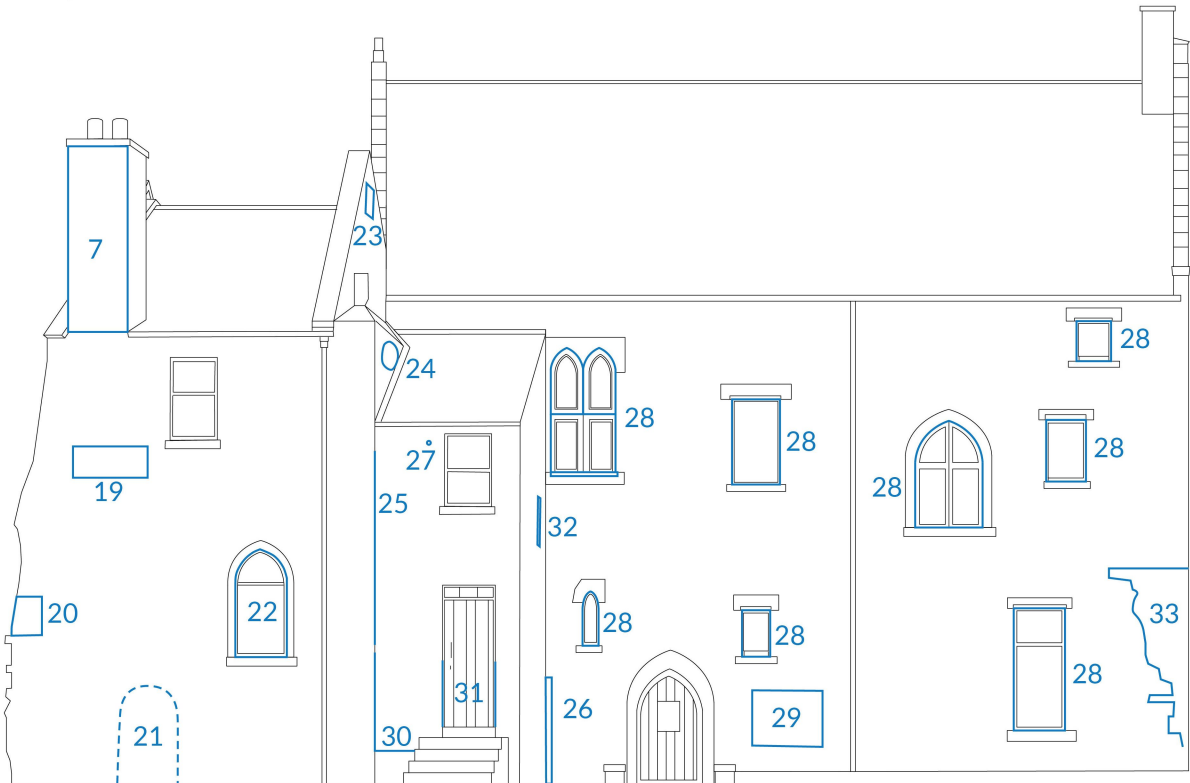
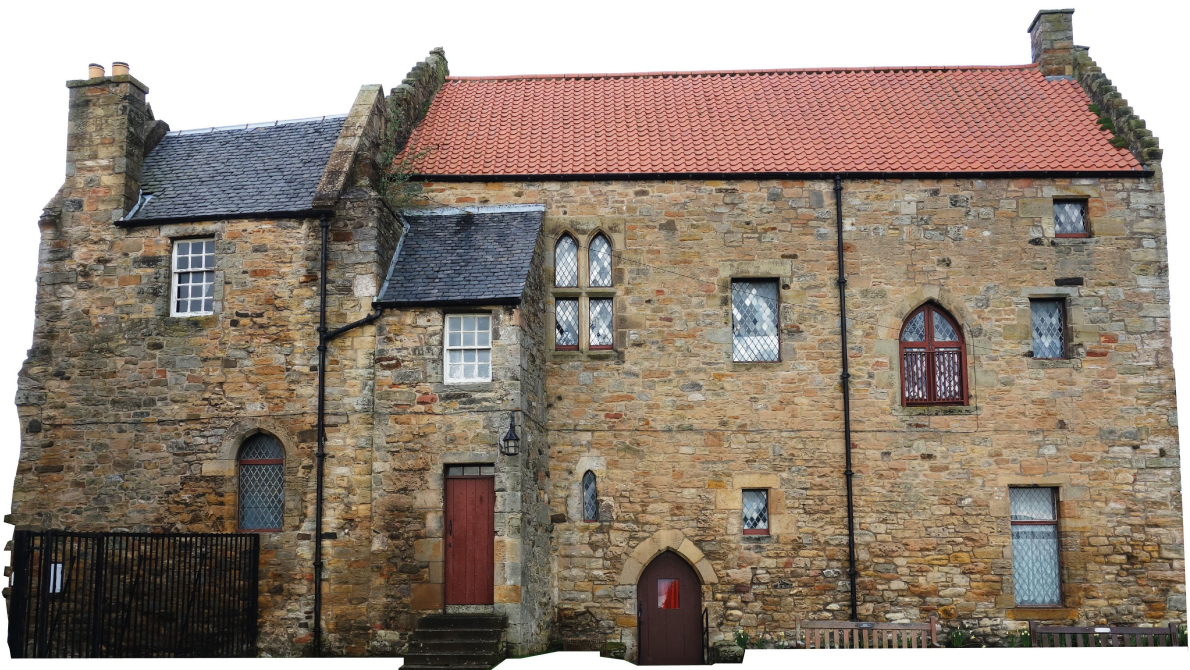
Illustration 10: East facing elevation (not to scale)

The east facing elevation (Illus. 10) was formed from the eastern walls of Area 1 and 3 along with the Newel stairwell (Area 4). The slightly different orientations of Area 1 and 3 was clear in the eastern elevation where the Newel stairwell (Area 4) had been built against the northern wall of Area 3 (Illus. 8). Here, the slit window (32) and the edge of the internal arch (26) at the end of the passageway (Room 3) were clearly visible on the northern wall of the stairwell Area 4.

The eastern wall of Area 1 contained numerous windows (28) of varying size and shape that all appeared to have been either inserted, remodelled or reinstated during the renovation works in the 1930s (Illus. 6 & 7). A blocked window (29) was also present on the ground floor while the stonework at the lower part of the northern end (33) appeared to be slightly different to the remainder of the wall.

The northern end of Area 3 held several distinct features including a possible blocked circular opening on the side of a chimney breast (24) and a possible blocked attic window (23). The main wall beneath these features also appeared to bow out slightly (25) resulting in sitting proud of the adjacent stairwell (Area 4).

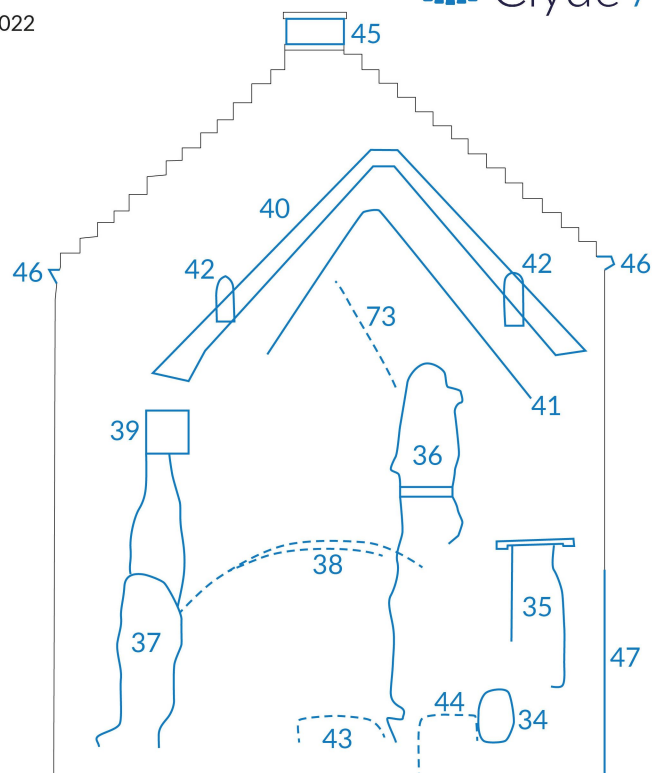
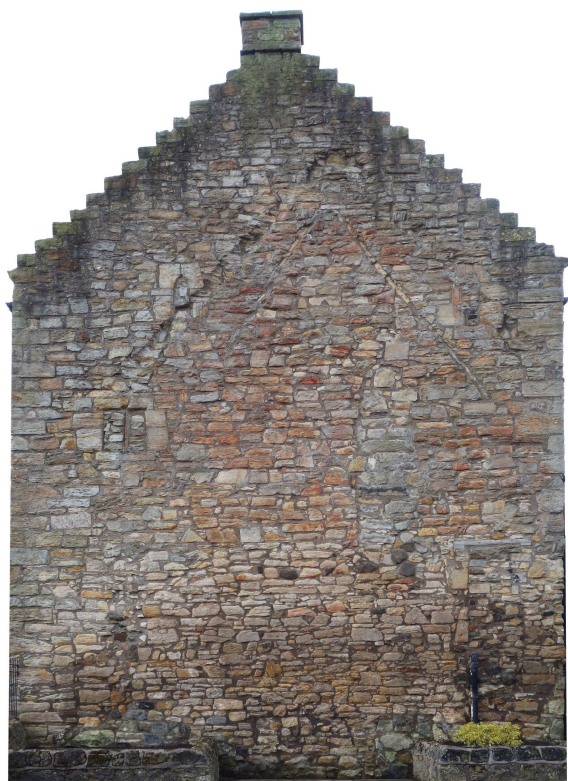
Illustration 11: North facing elevation (not to scale)

The northern elevation (Illus. 11) lay on the northern side of Area 1. Several distinct features were present on the single elevation. In the upper parts two former roof lines were present (40 & 41). The upper roofline (40) comprised a rough groove which cut through two blocked up gothic lancet windows (42), the western of which had a more rounded top. The lower roofline (41) was defined by flat copes. Just beneath these rooflines, on the eastern side of the elevation, was a small square blocked up window (39) beneath which lay possible infill (37) that could relate to former walls adjacent to or abutting the north elevation.

On the western side of the elevation changes in stonework (36), including a possible lintel, likely represent phases of modification. On the western edge of the elevation lay a likely blocked doorway (35) on top of which sat a wooden lintel. Adjacent to this no quoin stones were present on the corner of the building (47).

At the base of the elevation lay a patch of old plaster (34) and possible lines marking change in stonework (38, 43 & 44), some of which appeared to reuse dressed masonry (38).

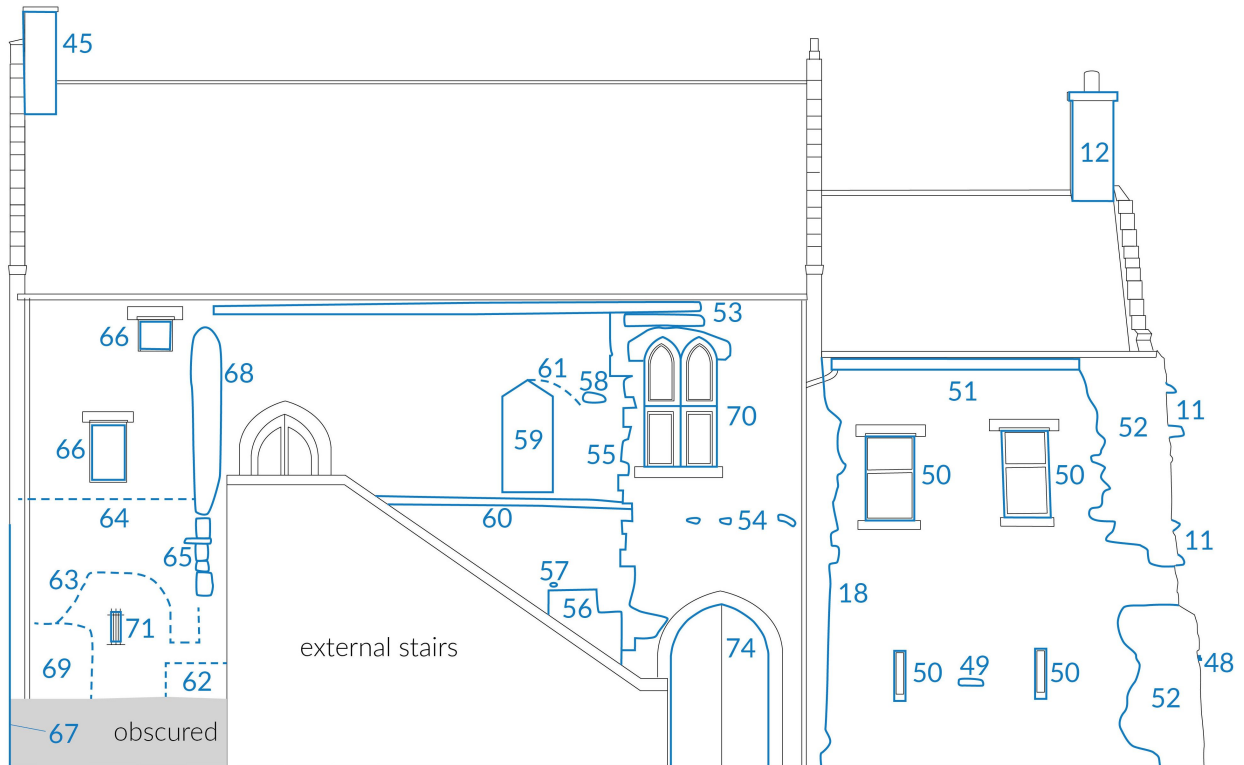
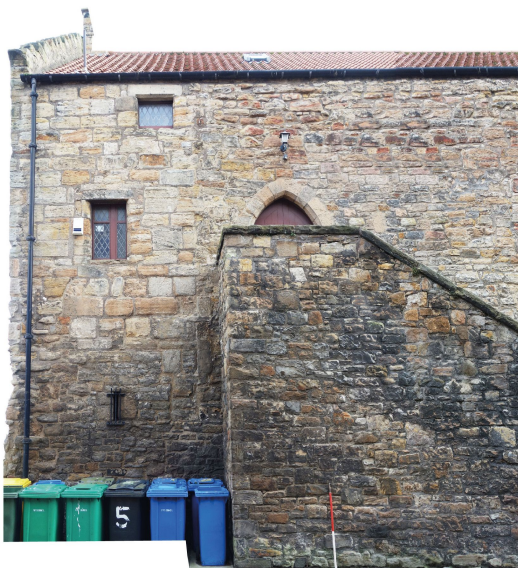
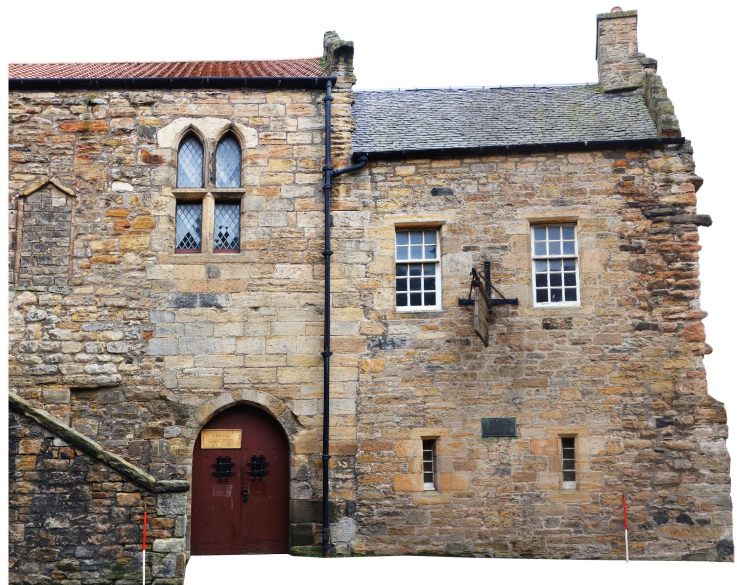
Illustration 12: West facing elevation, bottom left obscured by bins (not to scale)

The west facing elevation (Illus. 12) fronts onto Queen Street and currently provides the main access to Areas 1-4 through the street level main door (74) and the door at the top of an external stone staircase. Historic photos (Illus. 3 & 4) indicate that, prior to the 1930s refurbishment, one or two stone steps led up to the main ground floor door (74) suggesting the base of the door may have been lowered.

The southern end of the elevation appears to have been substantially rebuilt during renovation works in the 1930s when the external staircase at this end of the elevation was removed (Illus. 5). It is likely all four windows (50) were inserted at this time. More ragged walls at the southern corner (52) could indicate remains of older walls while the roof line appears to have been either raised or levelled (51).

Two very distinct changes in stonework (18 & 55) represent an area of the wall above the current main door (74) constructed of much more regular stone blocks than seen elsewhere on the elevation. The change in stonework is particularly vertical at the base of the southern edge where it meets Area 2.

To the north, and close to the base of the external stairway, which were likely rebuilt in the 1930s, lay an unusual recessed area (56) which could have been a former opening, although no lintel was present. Historic photos indicate this feature was here prior to the refurbishment in the 1930s and Stephens (1938: 53-54) suggest it had been a door to the ground floor. Above this lay what appeared to be a line of stone blocks (60) that could represent a former floor level. These continued north but were fainter at the northern end (64). This line ran along the base of a rectangular area with a pointed top (59) which may have represented a former opening. The infilled stone was recessed, however, the stone infill appears flush on historic photos taken prior to the refurbishment in the 1930s (Illus. 4). A possible curved change in stonework (61) above this feature may indicate the opening was once wider.

At the northern end of the elevation a slit window (71) corresponds to the location of the current toilet in the former circular stairwell (Room 2) and appears to have replaced a square window which was present prior to the 1930s refurbishment. Just below this a blocked doorway (62), possibly relating to that shown here on the RCAHMS survey prior to refurbishment (Illus. 2) was recorded as was an area of infilling (69) thought to relate to the 1930s refurbishment. Above this lay a line (63) marking a change in stonework while the base of the northern edge had no quoins present (67), see also (47) on the north facing elevation. A distinctive vertical line of stone blocks (65) lay half way up the elevation and appeared to continue into a ragged edge (68). The stonework to the north and south of 65 & 68 was clearly different and could represent significant remodelling of this northern end. Two windows (66) likely inserted/remodelled during the refurbishment in the 1930s were present at the top of the elevation.

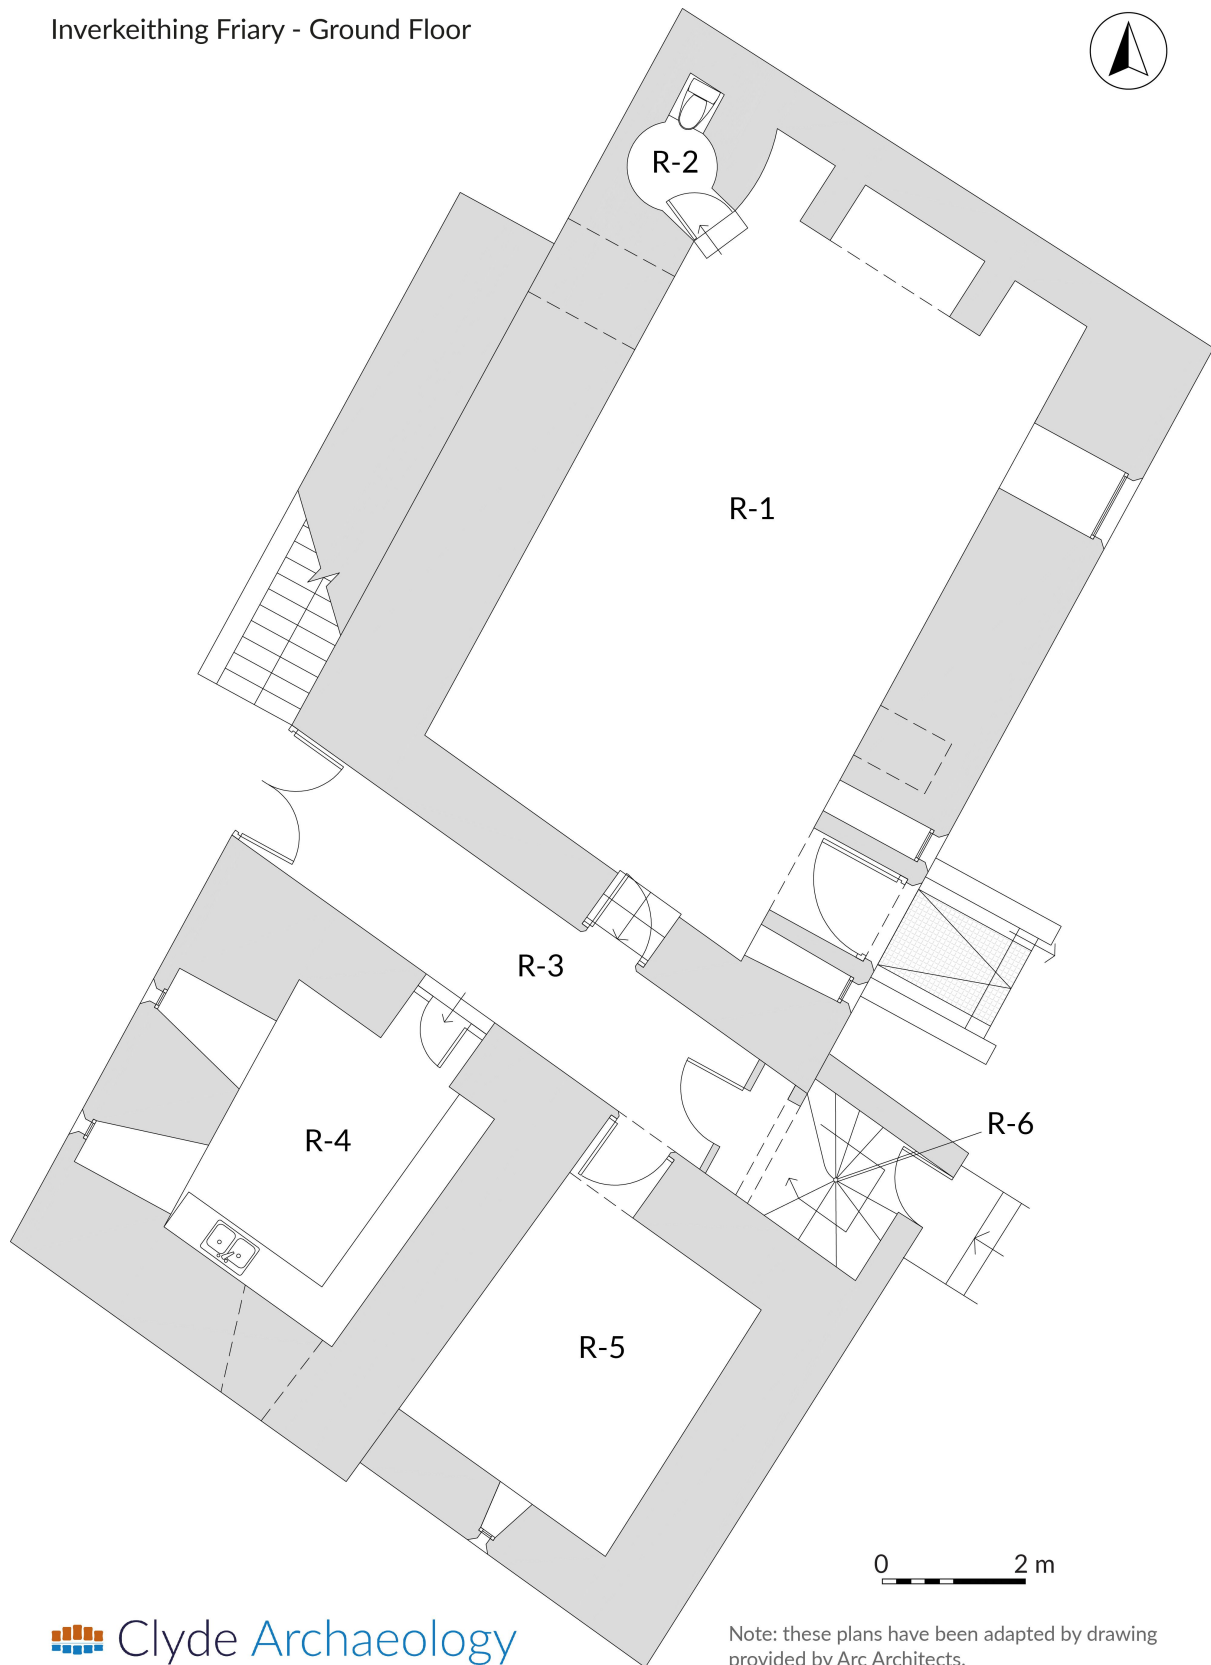
Illustration 13: Ground floor rooms

The ground floor (Illus. 13) consisted of three main rooms (1, 4 & 5) all accessed off a vaulted corridor (Room 3) which was likely once an open ended vennel or passageway before the eastern end was blocked by the construction of the Newel staircase (Room 6). Inside the main door, which now forms the western end of the passage, a gap between the vaulted ceiling and an inner rounded arch may be the result of packing material having fallen out (Illus. 14). The original eastern end of the passageway was defined by a pointed stone arch. Heavy iron hinges suggest it was once gated and likely represents the former exterior of the building before being enclosed by the Newel stairwell (Room 6).

The largest of the ground floor rooms (Room 1) was to the north of the passageway (Room 3). It had a high vaulted ceiling and was painted white. The top of the vault appeared off centre in relation to the fireplace which sat at the northern end of the room (Illus. 15). The RCAHMS survey records a wide arched fireplace (1933: 154) meaning it has subsequently been modified as it is no longer arched (Illus. 15). Stephen's account (1938: 52) notes that, other than part of the east and north walls, most of this area had been rebuilt in the 17th century.

A gap was clearly visible between the inner thick eastern wall and the outer wall containing the windows. No clear evidence was noted for the former doorway in the north-western corner or window in the south-eastern corner previously mapped by the RCAHMS (Illus. 2), but this could be due to the painted stonework.

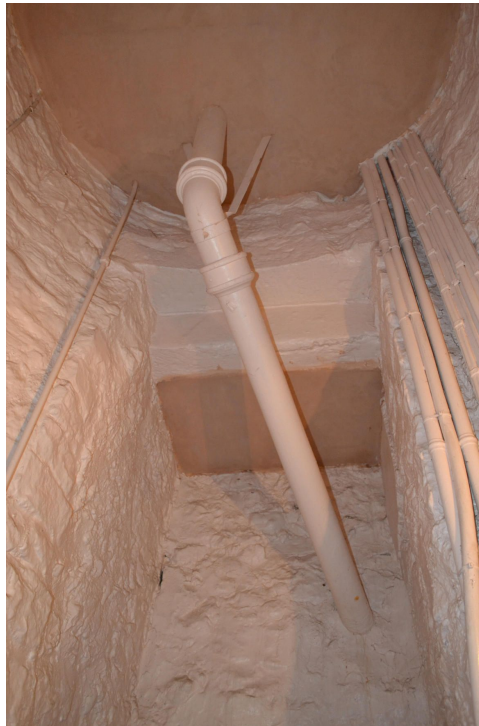
Illustration 16: Room 2 showing circular shape and straight sided recess in NE wall

A circular room, currently used as a toilet (Room 2), in the north-western corner of Room 1 likely once held a narrow Newel staircase. A small straight sided alcove on the north-eastern side (Illus. 2, 13 & 16) held the toilet, above which a stepped lintel like stone was present (Illus. 16). A white plastic down pipe above the toilet presumably ran into a black downpipe on the external northern elevation (Illus. 11 & 16), suggesting the alcove in Room 2 corresponds to the blocked doorway (35) on the northern elevation. However, wooden

lintel at the top of the blocked doorway (35) appeared higher than the lintel like stone in the Room 2 alcove. A narrow slit window was also present on the north-western wall of Room 2 behind an extraction fan.

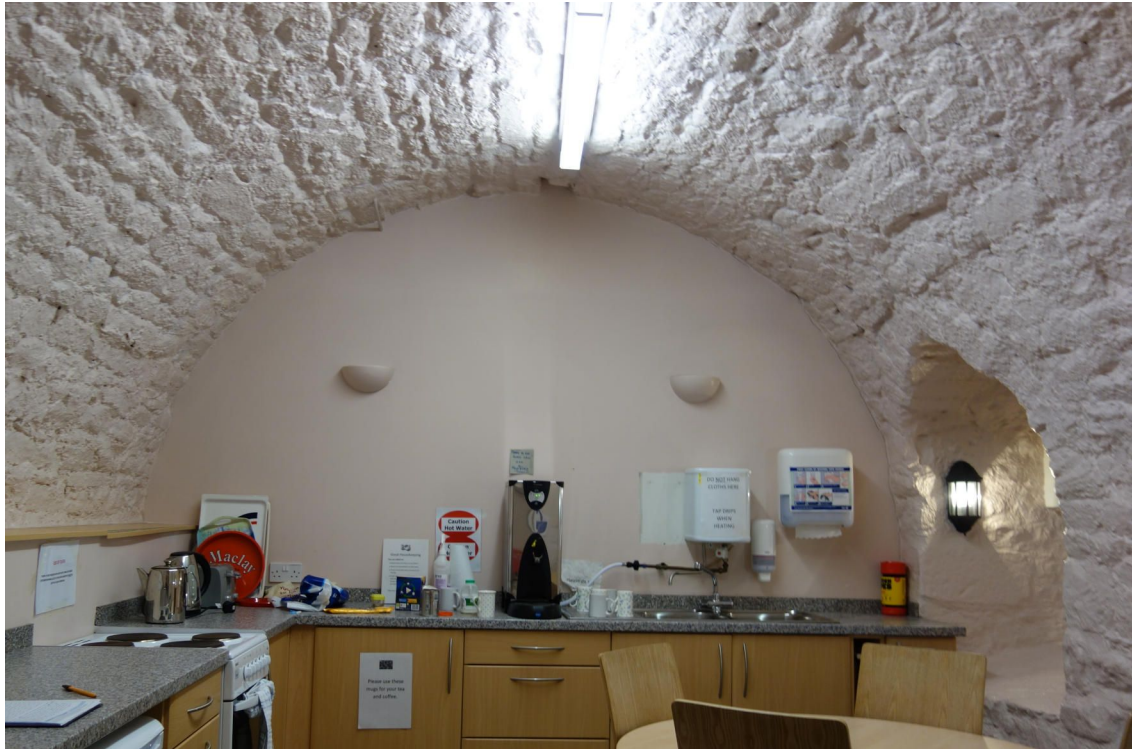
Illustration 17: Room 4. vaulted ceiling and plasterboard S wall

Room 4 is currently used as a kitchen. It had a vaulted ceiling (Illus. 17) and two deep window openings on the western wall, the northernmost of which had a distinct curve to the wall on the southern side.

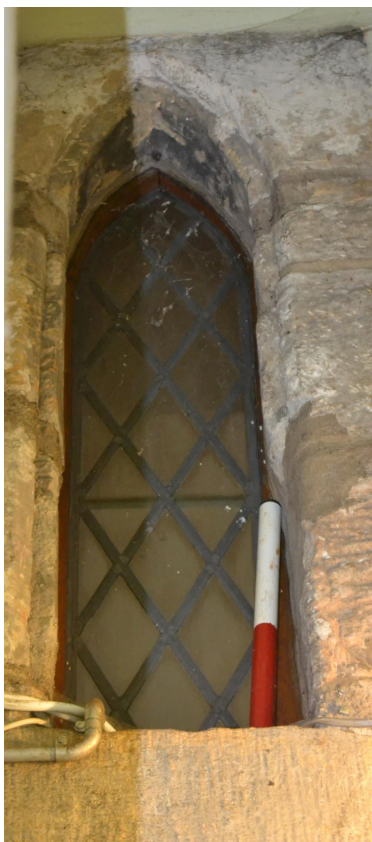
Illustration 18: Room 6, gothic lancet window at top of stairwell

The entrance to Area 3 was formed from dressed stone with rounded corners. Possible knife sharpening grooves were present on the western side of the door surround. A small gothic lancet window was present at the top of the stairs above the door into Room 7 (Illus. 18). The sill of the window was formed from the dressed stone surround of the doorway. A slit window was present in the north-eastern wall (Illus. 19).

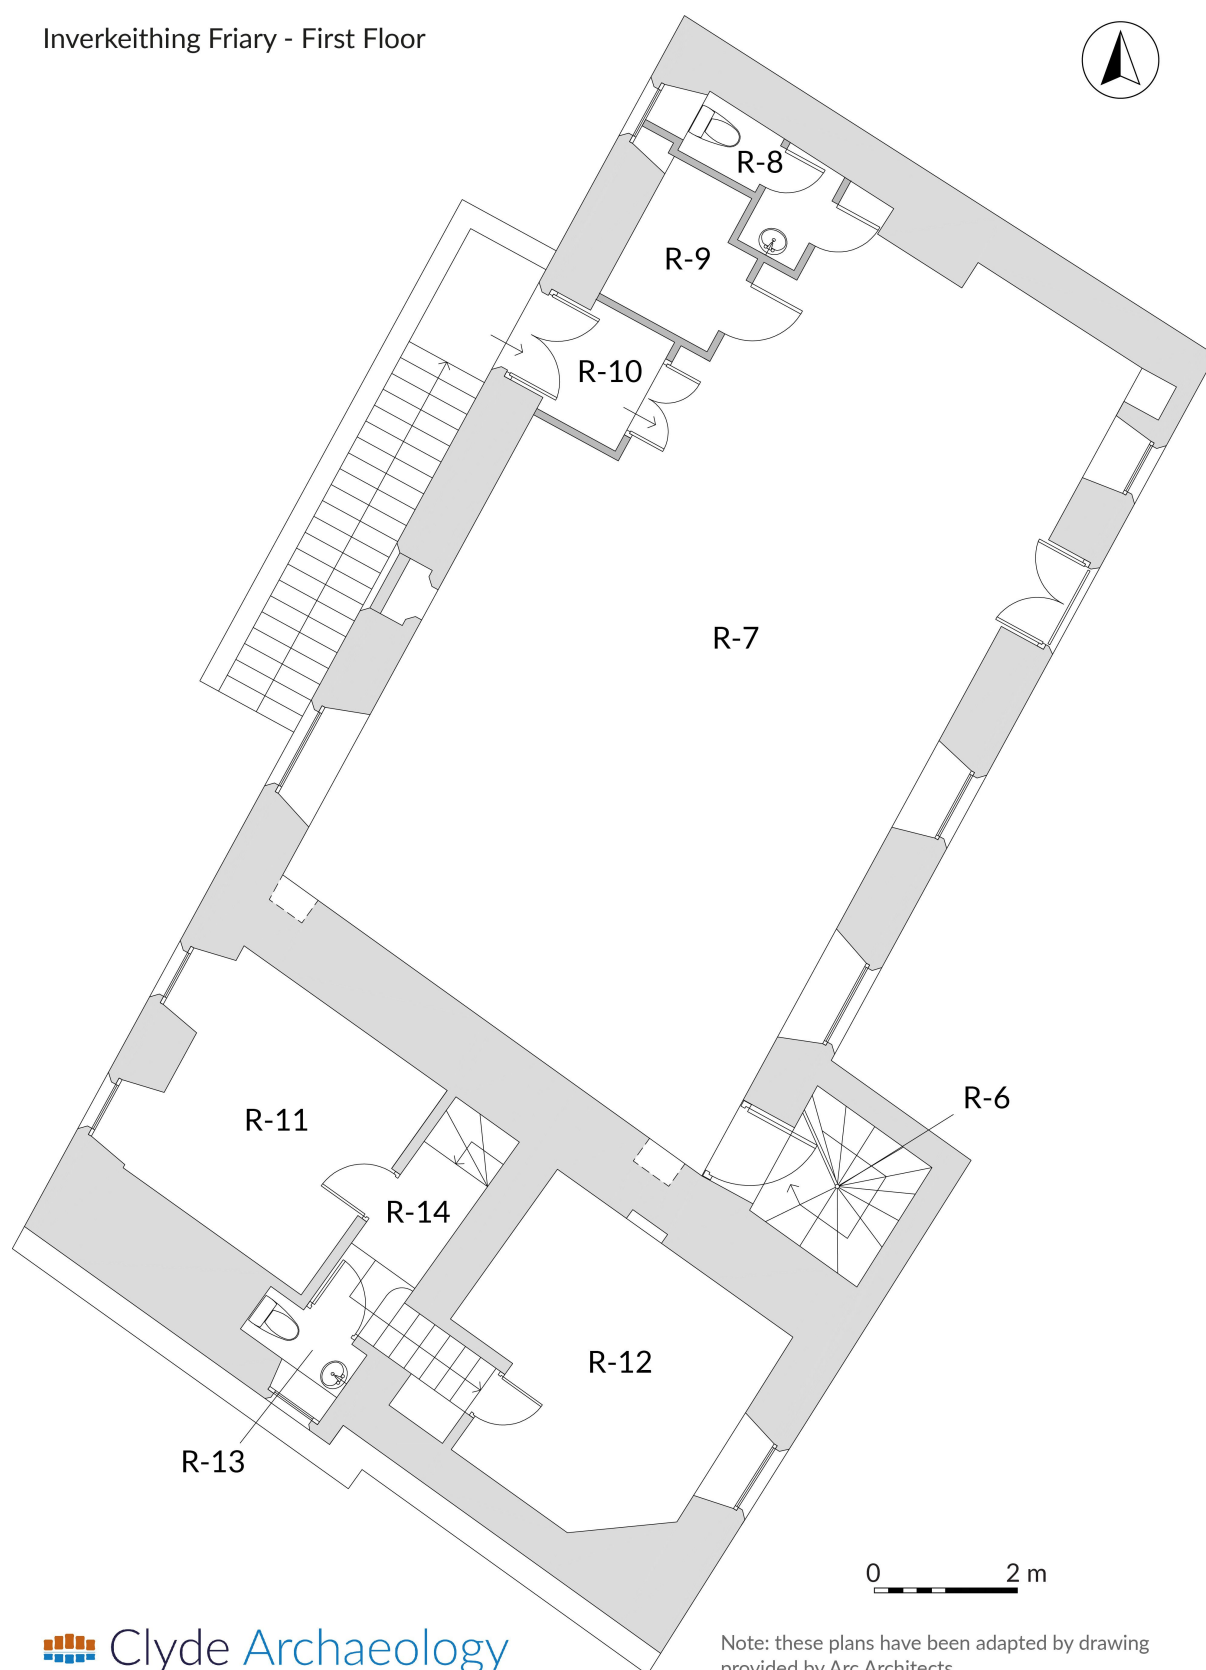
Illustration 20: First floor rooms

The largest room on the first floor (Room 7, Illus. 20) lay above Room 1 (Area 1) and the ground floor passageway (Room 3). It was formerly used as a museum and had a series of partition walls in the north-western corner forming a small toilet (Room 8), office (Room 9) and entrance vestibule (Room 10). The partition wall of Room 8 and 9 cut across half of the window in the western wall, beneath which the wall was curved. This likely represents a continuation of the circular stairwell forming Room 2 beneath.

The eastern wall had six windows of varying design, all of which appeared to have been either inserted or modified during renovation in the 1930s. Several small recesses with imitation stone backs adorned the walls. The most unusual lay midway along the western wall and consisted of possibly reused gothic lancet window surround (Illus. 21). South of this was a double gothic lancet window reinstated during the 1930s.

Areas 2 and 3 are accessed off the Newel staircase (Room 6). The floor of the lower portion of the hallway leading into Areas 2 and 3 (Room 14) appeared to be poured concrete and rose one step from the stairwell of Room 6. A window modified during the 1930s renovations lay on the eastern wall and the corridor curved to respect it. Beyond Room 15 (see below) the stairs were wooden where they also punctured through the western wall of Area 3 and eastern wall of Area 2. Here, the opening on the western side was formed from a dressed stone surround (Illus. 22). The corners of the stone had been cut flat like the doorway to Room 7 at the top of the Newel stairwell (Room 6). A possible 'W' like masons mark was present on the northern side at the base of the stone surround. A large recess at the top of the wooden stairs in the southern wall corresponded to the external feature (2) visible on the southern elevation (Illus. 9).

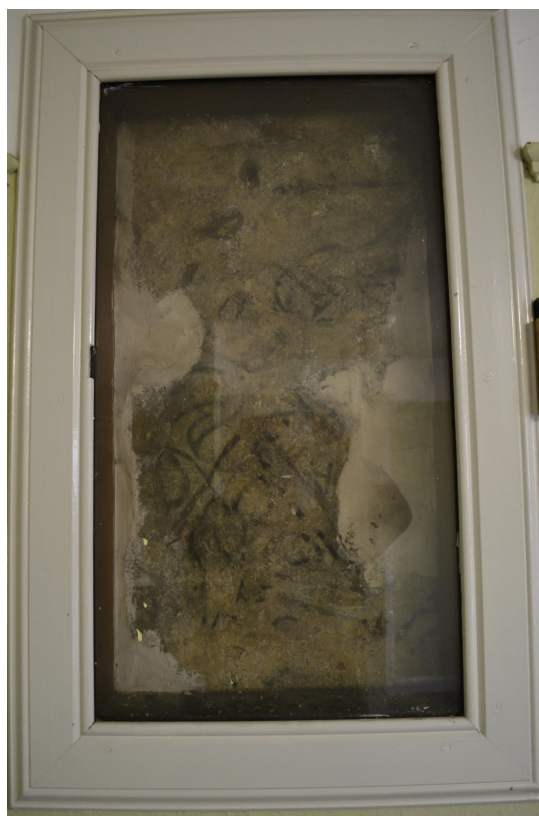
Illustration 23: Room 12, possible medieval plaster

Other than the remains of possible medieval decorated plaster, present on the northern wall and protected beneath glass (Illus. 23), only modern wall coverings and fittings were visible in Room 12. Room 13 is currently used as a toilet. The ground plan suggests this room lies within the thick southern wall of Area 2 (Illus. 20).

Given Inverkeithing Friary Hospitium is a category A listed building (LB35100) and has a complex history it is highly likely that further evidence for historical construction and use of the building is present behind some of the modern interior alterations and additions. If any future refurbishment of the friary is undertaken it is recommended that the works are monitored to allow recording of any significant historic features that may be revealed.

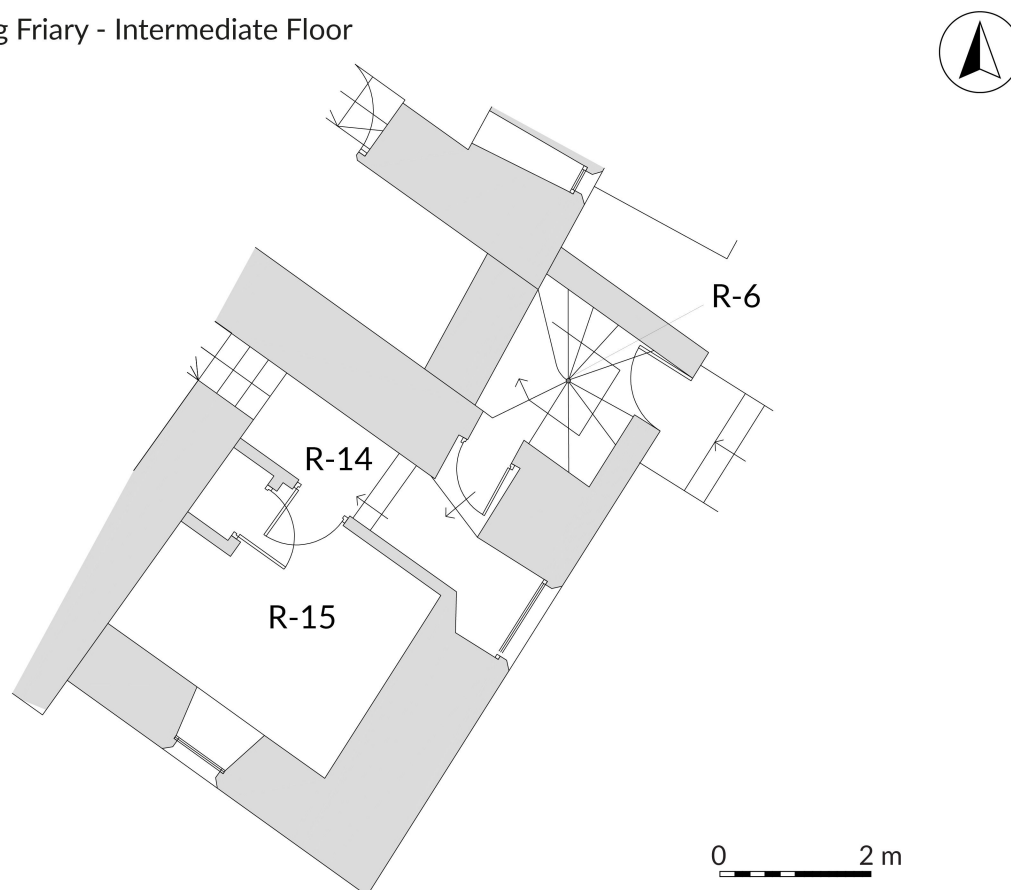
Illustration 24: Intermediate floor (Room 15)

Room 15 (Illus. 24) lay above the low vaulted Room 5 of Area 3 and itself had a low plastered vaulted ceiling. The northern wall appears to be a modern insertion as the vaulted ceiling continued beyond this into the hall (Room 14). A bricked up fireplace sat on the eastern wall while a slight angle in the north-eastern corner was likely a result of the hallway (Room 14) having to respect the window on the eastern external wall.
