TOP FLOOR FLAT, BONNYGATE, CUPAR

ESSENTIAL REPAIR, MAINTENANCE AND THERMAL UPGRADES

Energy Efficiency Case Study: Flat in Bonnygate, Cupar

19th March 2019

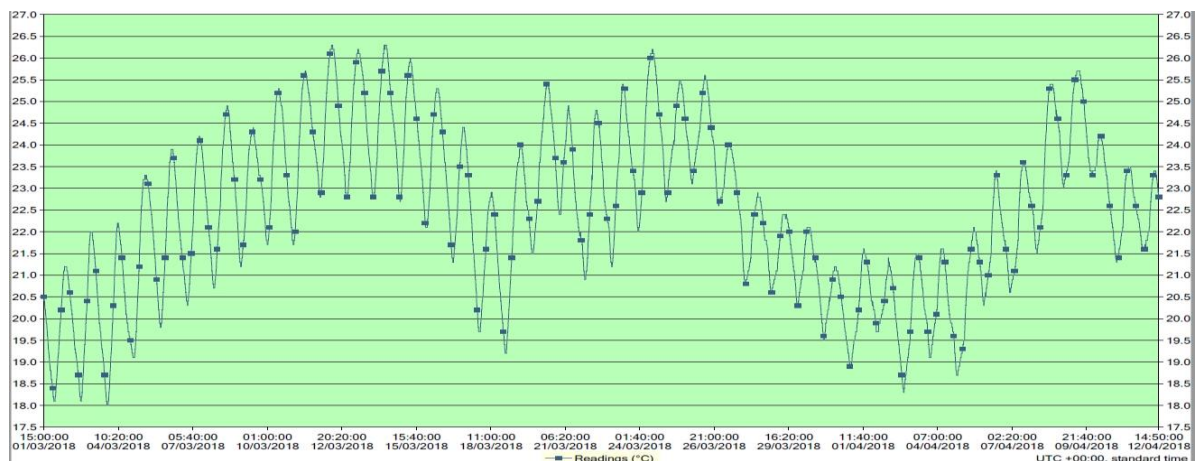
Fig. 22. Rear bedroom pre-works temperature

From log tag data, we can see that despite there only being a 0.6 °C difference (lower in the post-works phase) in the average internal temperature, there was a trend of steadier temperature (lesser extremes of high and low temperatures) with typical daily swings reducing from 5 °C to 3 °C as can be seen in the before and after graphs for the rear bedroom.

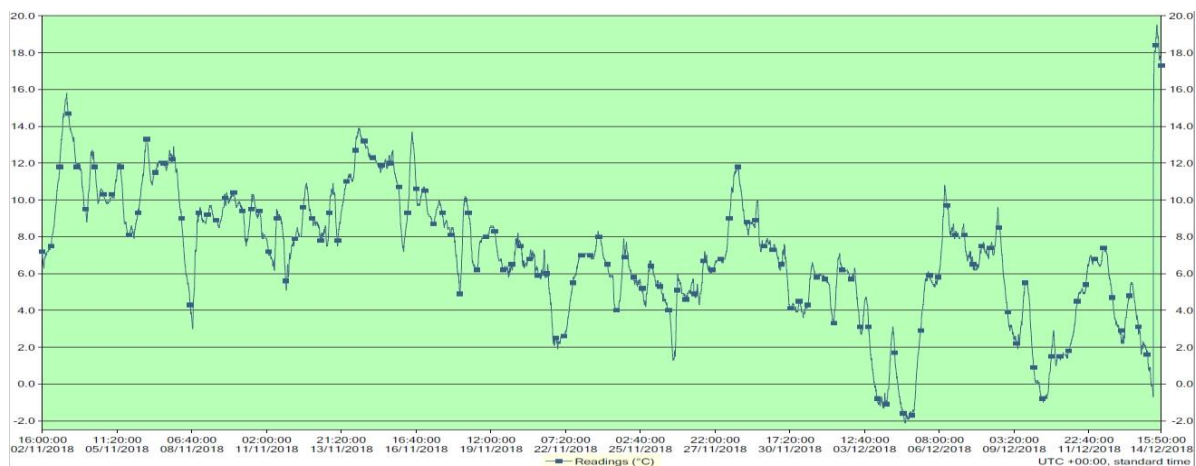
Fig. 24. Post-works external (Cupar) temperature

It is worth noting that there seems to be a correlation between external weather and internal temperature, as the internal temperature seems to shift with a lag of a few days, following shifts in external temperatures. This can be seen on the post-works external Cupar temperature graph (Fig. 24) below. We note that internal temperature spikes could relate to solar gain but, as we did not record this data, we have no way of proving this.
