A Building Stone Survey for Cupar Conservation Area, Cupar, Fife

Carried out by the Scottish Lime Centre Trust

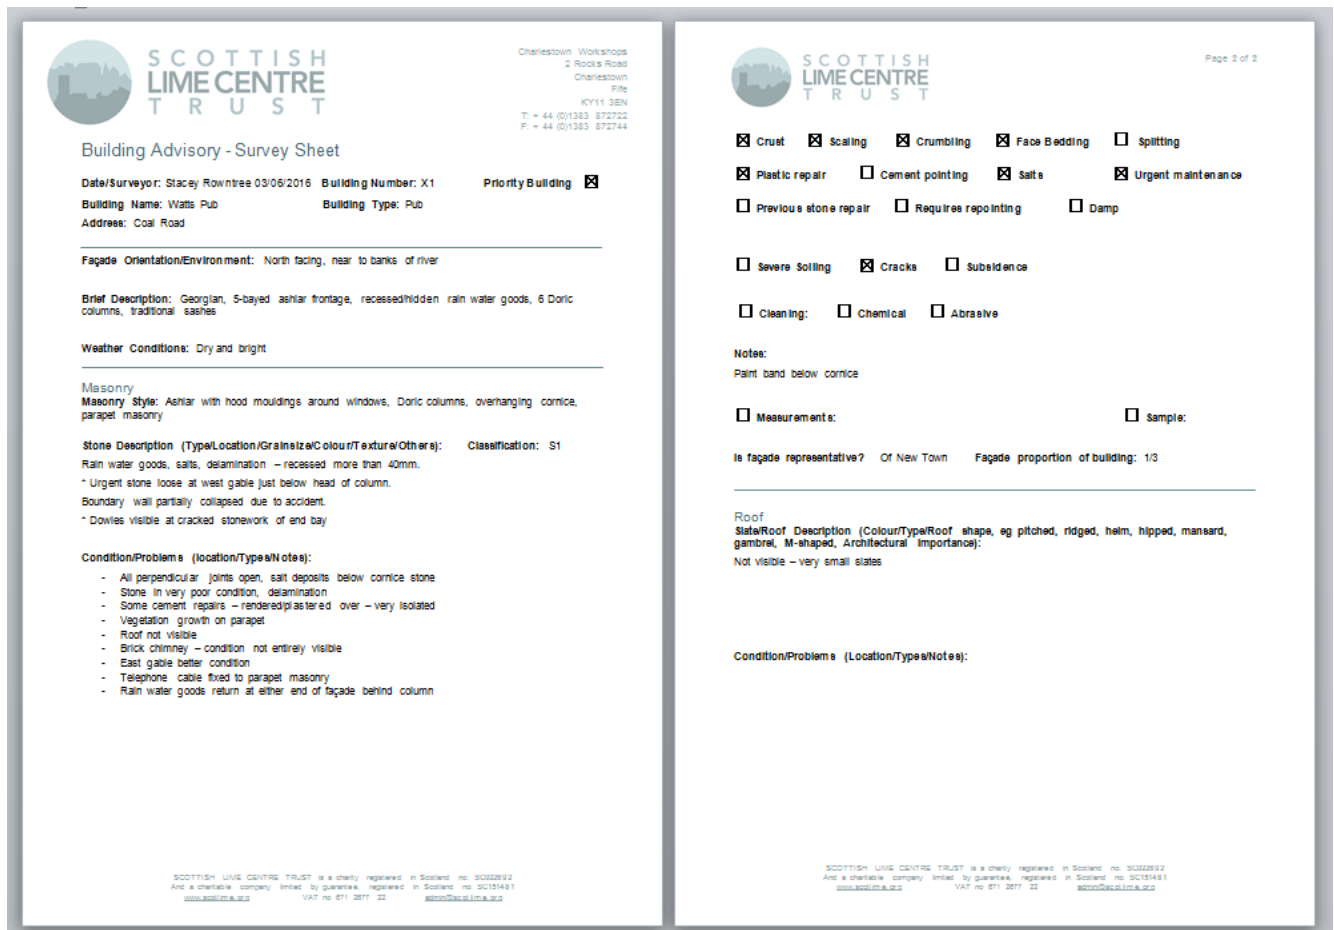
- Stone Description (Type/Location/Grain/size/Colour/Texture/Other):** Classification: S1. Rain water goods, salts, delamination - recessed more than 40mm. * Urgent stone loose at west gable just below head of column. Boundary wall partially collapsed due to accident. * Dowels visible at cracked stonework of end bay.

- Condition/Problems (Location/Type/Notes):**
 - All perpendicular joints open, salt deposits below cornice stone
 - Stone in very poor condition, delamination

- Some cement repairs - rendered/plastered over - very isolated
 - Vegetation growth on parapet
 - Roof not visible
 - Brick chimney - condition not entirely visible

- East gable better condition
 - Telephone cable fixed to parapet masonry
 - Rain water goods return at either end of facade behind column

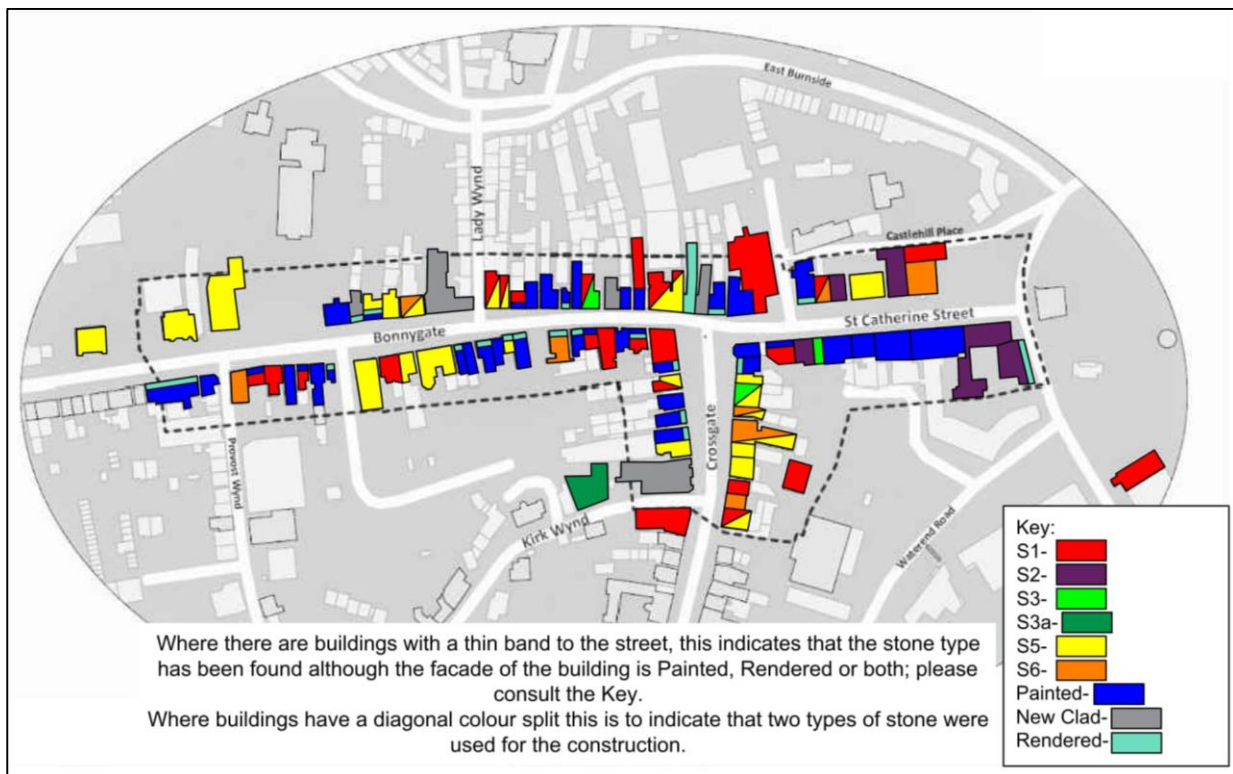
Figure 12: Distribution of stone types within the principle street elevations of the Cupar Priority Area. Map © Crown copyright and database rights 2015 Ordnance Survey 100023385.

Sandstone type S1 is described as the generic local sandstone used in Cupar, displaying a range of sedimentary structures, textures and decay features. This stone type was present in the majority of the oldest buildings in Cupar, generally suffered from a greater range of decay processes and were in a poorer condition in relation to the other sandstone types. Sandstone types S5 and S6, as previously distinguished from type S1, are listed within Figure 12 and Figure 13, and are in generally better condition than those initially classified as type S1. This difference in stone quality between types S1, S5 and S6 is explained by the natural variation in stone properties, as a function of the subtle variation in the depositional environment and diagenetic processes, from within and between different beds within the same quarry or from the differences between different quarries working the same sandstone formation. Additionally, each block extracted from the same quarry has the potential to vary in its weathering behaviour over a period of years in accordance to the weather conditions, the stone extraction process, and it's functionally within a building.

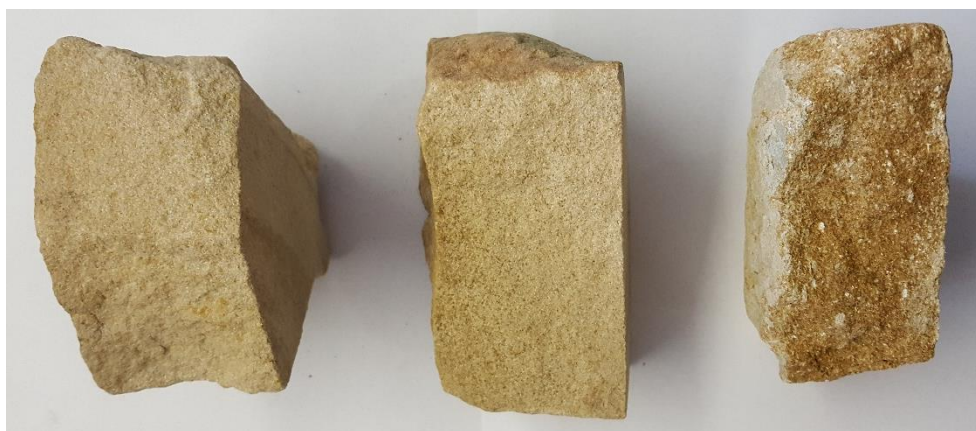
Figure 21: Three samples representative of sandstone produced at Drumdryan Quarry. **(right):** the lowest accessible bed, characterised by dark colour, Fe-oxides and large swelling clay inclusions. **(middle):** the middle beds from the quarry show some variability, with characteristic orange-brown mottling. **(left):** top beds from the quarry are of better quality and lower spatial variation.

Petrographic analysis of the middle and top beds of sandstone from Drumdryan Quarry show some similarities to the sandstone from Cupar (Figure 21). Both beds are fine-grained, well graded, texturally sub-mature and mineralogically mature quartz arenite sandstones that contain a lower overall proportion of Fe-oxides and clay than Cupar samples, and show no evidence of calcite or

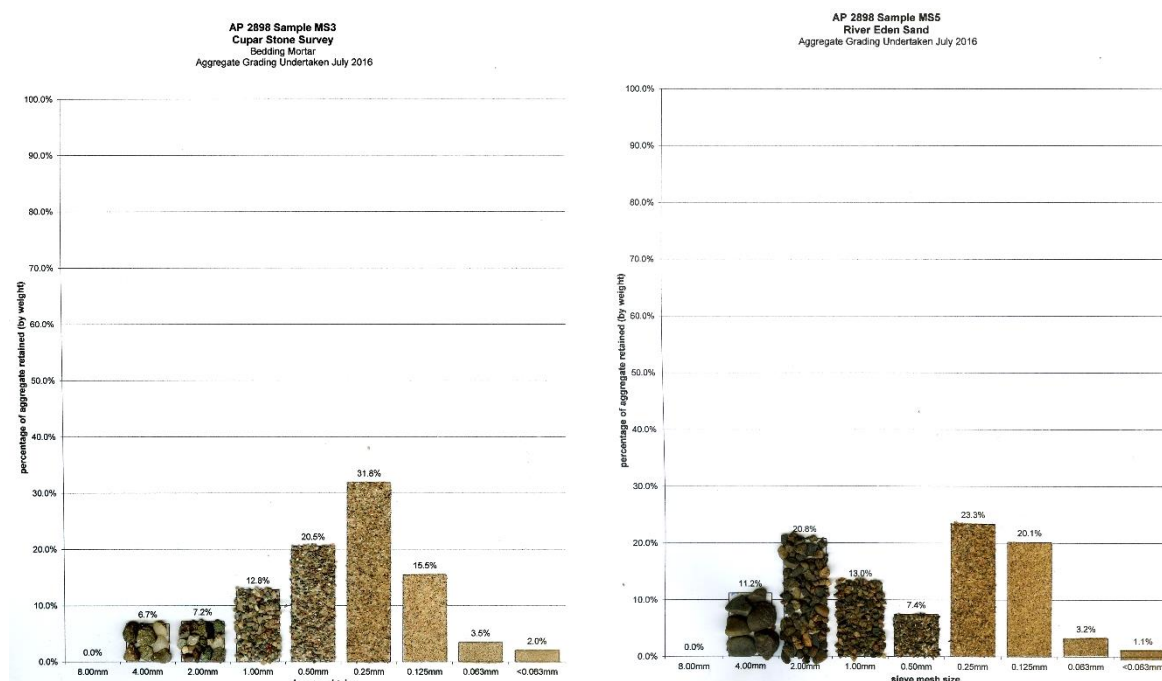
Aggregate was likely obtained from a mixture of locations around Cupar, including similar superficial deposits as those currently acquired from Melville Gates Quarry. Representative sand was obtained from the River Eden, East of Cupar in order to ascertain whether this might have been used as the original source material for mortar aggregate (Figure 24). When the largest aggregate fragments were subtracted from the sand, slight similarities in mineralogy and texture to the aggregate obtained from the mortar are evident, however the sand gradings did not match (Figure 24). This mismatch in aggregate grading might be explained by the location of where sand was dredged from the River

Figure 24: Aggregate grading profiles from bedding mortar, MS3 (left) and from the River Eden (right).

Eden; with the finest sediment likely to have been deposited on point bars and on the inside bends of rivers, while coarse aggregate is likely obtained from the river bed and outside bends. It is recommended that representative building sand from Melville Gates Quarry is used for mortar repair work throughout Cupar; providing similar grain size distributions, mineralogy, colour and texture. The use of alternative aggregates, as provided in the relevant mortar analysis reports (Appendix D) should only be sought in the event where building sand from Melville Gates Quarry is unavailable.

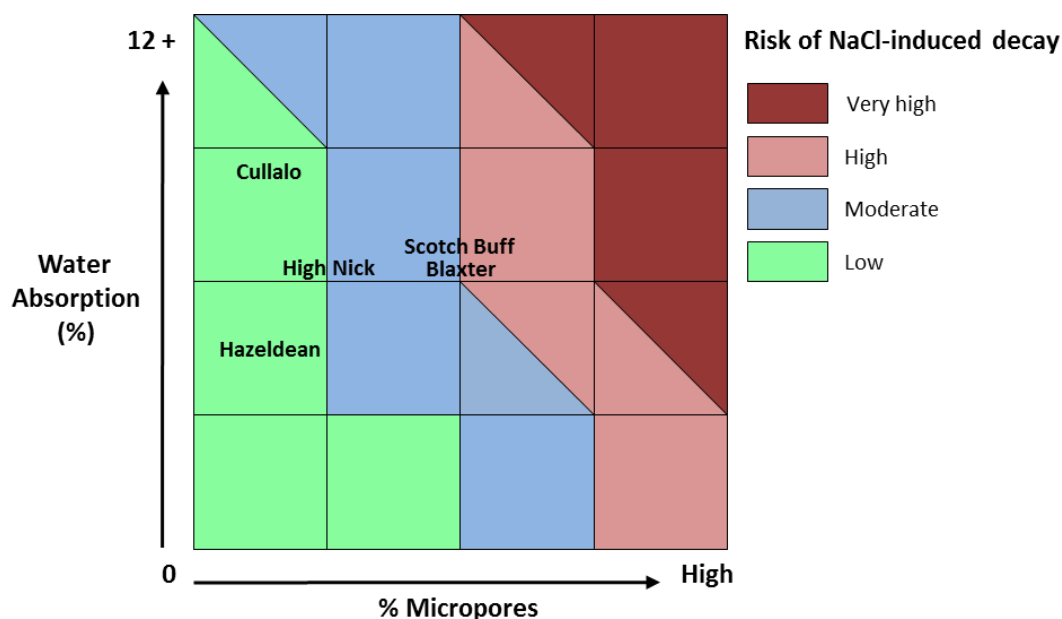
Figure 25: NaCl crystallisation damage matrix, overprinted with matching sandstones for Cupar.

Research has revealed that specific pore-structural properties of sandstone can significantly influence their durability/vulnerability to salt-crystallisation damage from sodium chloride (NaCl / rock salt); which is the most widely used de-icing salt in Scotland (Graham, 2016). By using the sandstone vulnerability estimator which is based on the pore size distribution and water absorption of sandstone (Graham, 2016), the most salt-resilient matching sandstones for Cupar can be identified (Figure 25). Table 9 shows the most appropriate matching sandstones for types S1 (incorporating S5 and S6), in order of resilience to salt crystallisation damage. These sandstone types should be used in regions vulnerable to salt crystallisation damage. Figure 25 highlights the overall vulnerability of matching sandstones to NaCl-crystallisation damage. Hazeldean and Cullalo are very resistant to NaCl-induced decay, and therefore both are suitable replacement sandstone matches for areas of high salt damage.
